CONDITION REPORT

Report No: 2016201940

Vehicle Type	LIGHT LOAD VEHICLE	Registered Owner	MFC
Manufacturer	FORD	Registration Number	KMB957MP
Model	RANGER	Register Number	
VIN	AFANXXMJ2NJM08832	Date Of First Licensing	
Engine Number		Last COR	
Doors	2	License Expiry Date	31/12/2022
Color	WHITE	Power / Displacement	
Year Model		Paint Finish	TWO COAT METALLIC
Km Reading	168,094 KM	Fuel	PETROL
Cab / Body Type	SINGLE CAB	Transmission	MANUAL

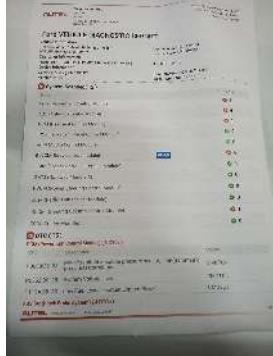
Brake and shock test

Left	Right	Axle Weight [KG]	Deceleration [m/s ²]
	Braking Force [KN]	Braking Force [KN]		
Front	3.41	3.59	-	
Rear	1.47	2.75	-	
Emergency / Parking	1.23	2.06	-

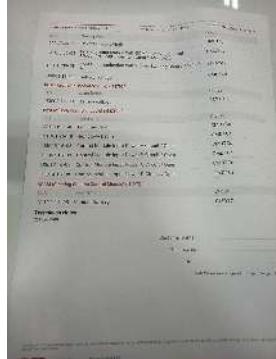
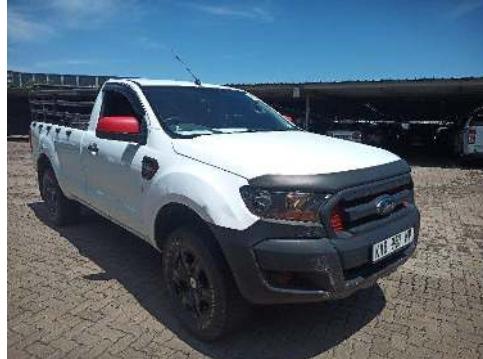
Diagnostic report

During the diagnostic no active error messages were detected. (See also attached Diagnostic Report. For more information regarding the Fault Codes (DTC) and the recommended rectifications please contact the workshops of the vehicle manufacture).

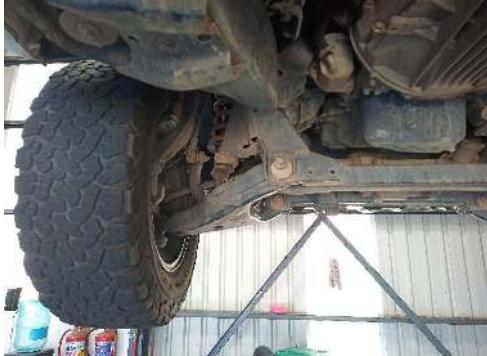
LF TYRE TREAD

Size	Load/Speed Index	Manufacture	Model	Type*	Production Date	Tread Depth (mm)
Front Left	265/65R17	120S	BFGOODRICH	Radial	V	1120	1 mm
Front Right	265/65R17	112S	BFGoodrich	Radial	V	3620	0 mm
Rear Left	265/65R17	112S	BFGoodrich	Radial	V	1120	2 mm
Rear Right	265/65R17	112S	BFGoodrich	Radial	V	3620	0 mm
