MFC Auction House  
M57 Pretoria Rd, Glenmarais, KEMPTON PARK  
Gauteng

| Vehicle Type | PASSENGER VEHICLE | Registered Owner | MFC |
| Manufacturer | TOYOTA | Registration Number | JMP505MP |

## VEHICLE INSPECTION

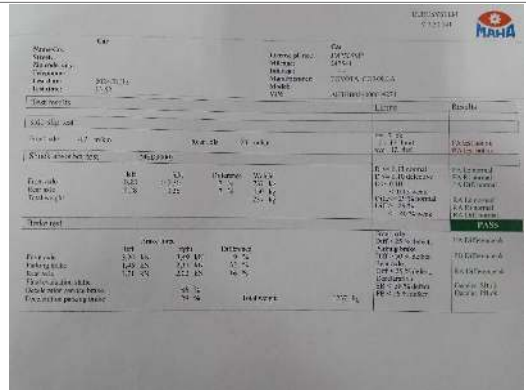
Brake and shock absorber report

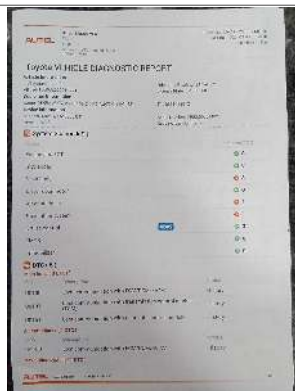
| No | System | Code | Description | Status |
|---|---|---|---|---|
| 1 | MAIN BODY | U0100 | LOST COMMUNICATION WITH ECM/PCM/ECU"A" | |

Diagnostic report page 1

Diagnostic report page 2

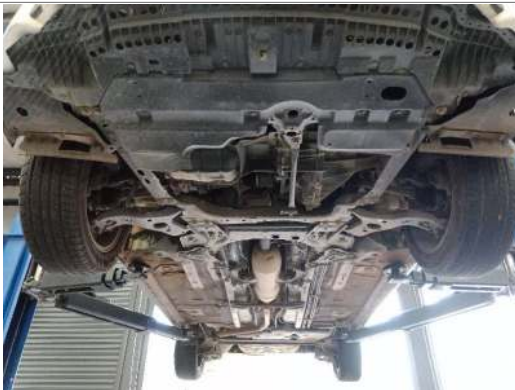
Front chassis

Chassis Scratched  
Engine to silencer pipe Defective  
Belly plates Defective  
Jack Missing  
Wheel Spanner Missing  
Triangle Missing

Repair  
Repair  
Repair  
Replace  
Replace  
Replace

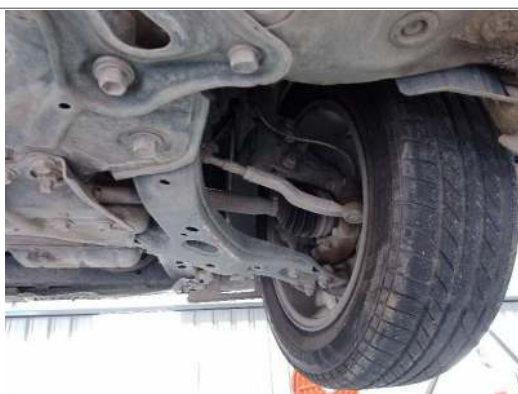
| | Size | Load/Speed Index | Manufacture | Model | Type* | Production Date | Tread Depth (mm) |
|---|---|---|---|---|---|---|---|
| Front Right | 205/55 R16 | 91V | Continental | Sport | V | 3215 | 6 mm |

RF TYRE TREAD

| Damage | Repair Way |
|---|---|
| Tyre Front Right Defective | Replace |
