CONDITION REPORT

Report No: 2016202109

| Manufacturer | TOYOTA | Registration Number | JK80RGGP |
| Model | COROLLA | Register Number | |

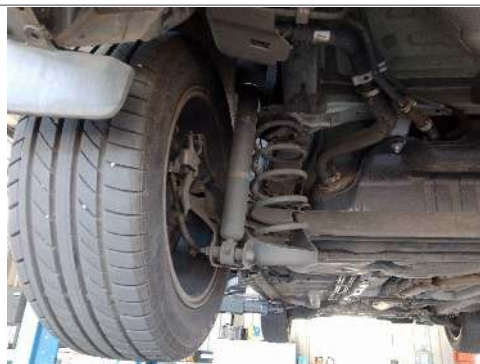
LR TYRE TREAD

| | Size | Load/Speed Index | Manufacture | Model | Type* | Production Date | Tread Depth (mm) |
|---|---|---|---|---|---|---|---|
| Rear Left | 205/55 R16 | 91V | Continental | Sport | V | 3717 | 5 mm |

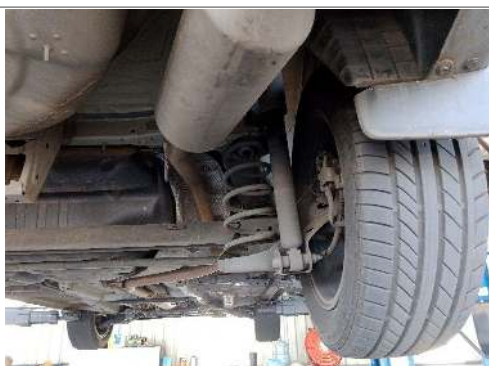
RR TYRE TREAD

| | Size | Load/Speed Index | Manufacture | Model | Type* | Production Date | Tread Depth (mm) |
|---|---|---|---|---|---|---|---|
| Rear Right | 205/55 R16 | 91V | Continental | Sport | V | 3717 | 6 mm |

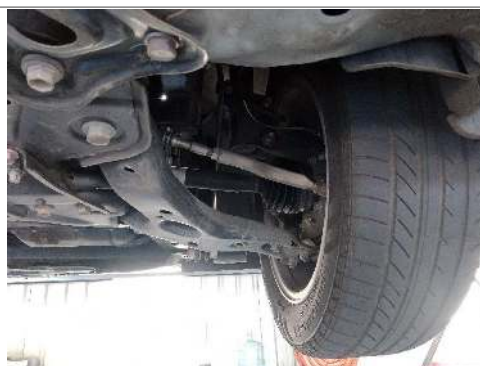
RF TYRE TREAD

| | Size | Load/Speed Index | Manufacture | Model | Type* | Production Date | Tread Depth (mm) |
|---|---|---|---|---|---|---|---|
| Front Right | 205/55 R16 | 91V | Continental | Sport | V | 3717 | 3 mm |

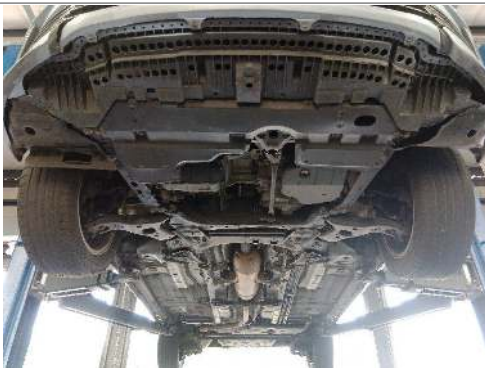
Front chassis

| Damage | Repair Way |
|---|---|
| Chassis Scratched | Repair |
