MFC Auction House  
M57 Pretoria Rd, Glenmarais, KEMPTON PARK  
Gauteng

| Manufacturer | TOYOTA | Registration Number | JVW818NW |

## CONDITION REPORT

Report No: 2016664530

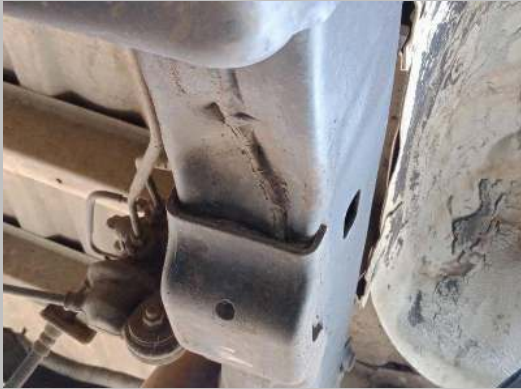
| Damage | Repair Way |
|---|---|
| Main Beam Left Dented | Repair |
