## CONDITION REPORT

Report No:  
2016903257  
DATE  
05/06/2025

| Manufacturer | TOYOTA | Registration Number | FZT446L |
| Model | HILUX 2.8 GD-6 RB RAIDER D-CAB DSL PU AT [2016-2018] | Register Number | |

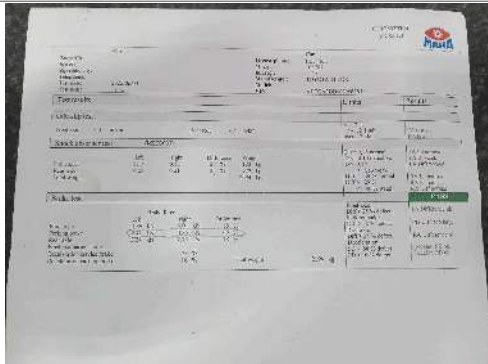
Shock and brake report

| Parking Brake Performance Left / Right Difference out of legal range | Repair |

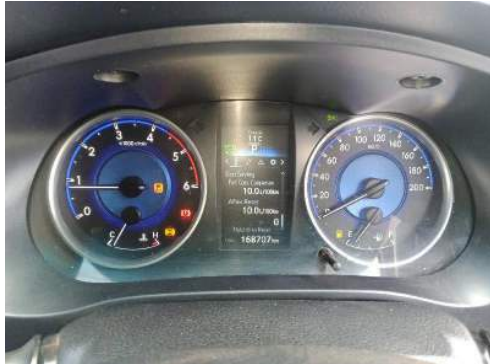
DASHBOARD (W/ ENGINE RUNNING)

| ABS and traction control, brake pads light on | Repair |

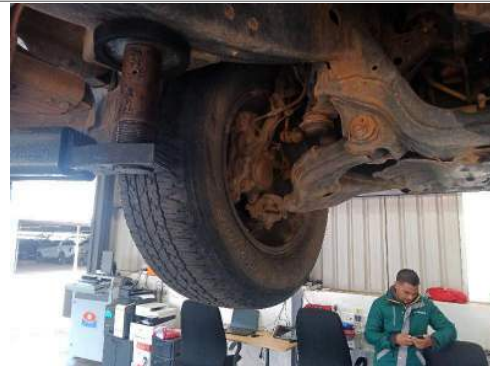
LF TYRE TREAD

| | Size | Load/Speed Index | Manufacture | Model | Type* | Production Date | Tread Depth (mm) |
|---|---|---|---|---|---|---|---|
| Front Left | 265/65R17 | 112S | Bridgestone | Dueller | V | 0321 | 3 mm |

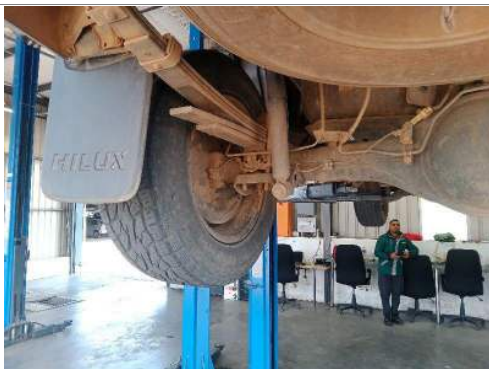
LR TYRE TREAD

| Rear tires deferred name brand and sizes | Repair |

| | Size | Load/Speed Index | Manufacture | Model | Type* | Production Date | Tread Depth (mm) |
|---|---|---|---|---|---|---|---|
| Rear Left | 245/65R17 | 111T | Ling long | Crosswind | V | 2521 | 4 mm |

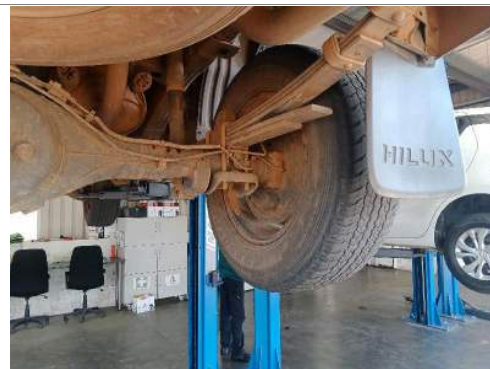
RR TYRE TREAD

| | Size | Load/Speed Index | Manufacture | Model | Type* | Production Date | Tread Depth (mm) |
|---|---|---|---|---|---|---|---|
| Rear Right | 265/65R17 | 112S | Dunlop | Grandtrek | V | 3919 | 2 mm |

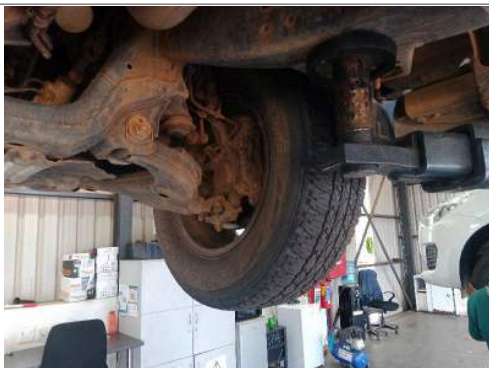
RF TYRE TREAD

| | Size | Load/Speed Index | Manufacture | Model | Type* | Production Date | Tread Depth (mm) |
|---|---|---|---|---|---|---|---|
| Front Right | 265/65R17 | 112S | Bridgestone | Dueller | V | 0321 | 4 mm |

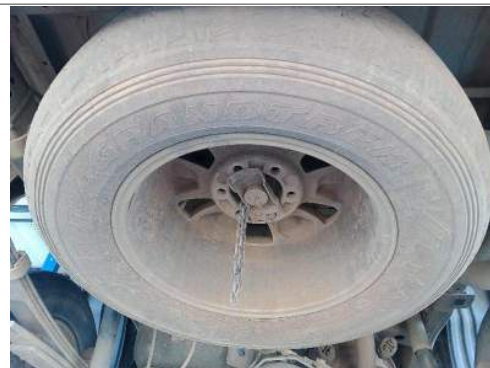
Spare wheel

| Spare Tyre Smooth | Replace |

| | Size | Load/Speed Index | Manufacture | Model | Type* | Production Date | Tread Depth (mm) |
|---|---|---|---|---|---|---|---|
| Spare | 265/65R17 | 112S | Dunlop | Grandtrek | V | 0718 | 0 mm |

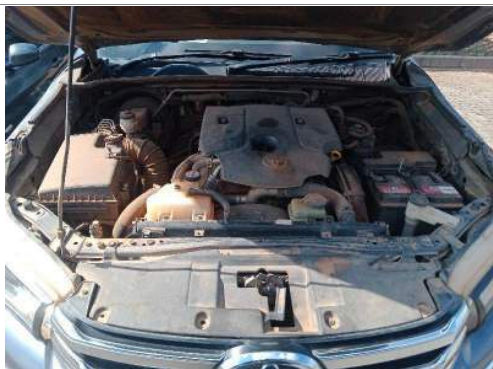
ENGINE 1

| Engine Oil Sweat | Repair |

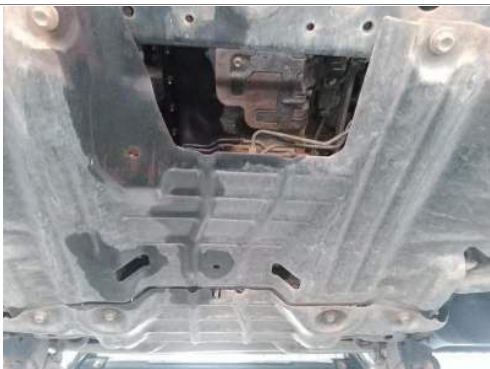
ENGINE 2

| Oil cap damage | Replace |
