MFC Auction House  
M57 Pretoria Rd, Glenmarais, KEMPTON PARK  
Gauteng

## Assignment

Report No: 2016322467

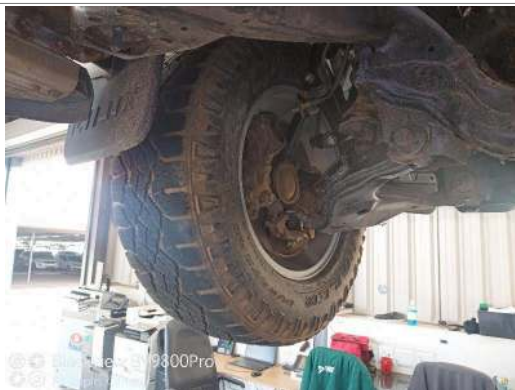
LF TYRE TREAD

| | Size | Load/Speed Index | Manufacture | Model | Type* | Production Date | Tread Depth (mm) |
|---|---|---|---|---|---|---|---|
| Front Left | 265/65R17 | 112Q | Goodyear | Wrangler | V | 4918 | 3 mm |

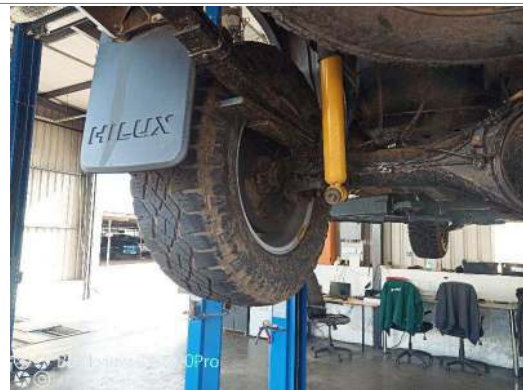
LR TYRE TREAD

| | Size | Load/Speed Index | Manufacture | Model | Type* | Production Date | Tread Depth (mm) |
|---|---|---|---|---|---|---|---|
| Rear Left | 265/65R17 | 112Q | Goodyear | Wrangler | V | 5118 | 3 mm |

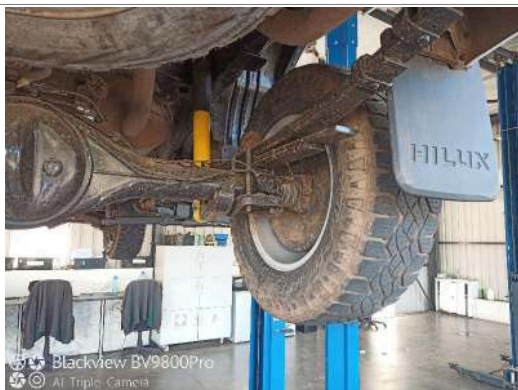
RR TYRE TREAD

| | Size | Load/Speed Index | Manufacture | Model | Type* | Production Date | Tread Depth (mm) |
|---|---|---|---|---|---|---|---|
| Rear Right | 265/65R17 | 112Q | Goodyear | Wrangler | V | 4918 | 4 mm |

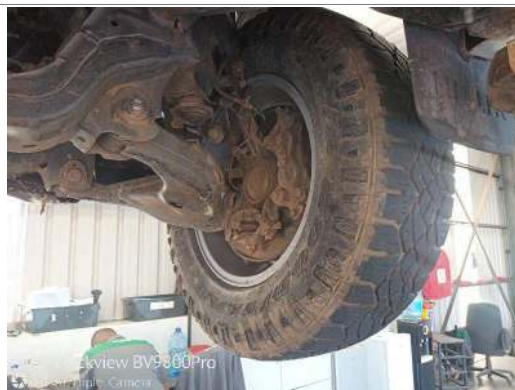
RF TYRE TREAD

| | Size | Load/Speed Index | Manufacture | Model | Type* | Production Date | Tread Depth (mm) |
|---|---|---|---|---|---|---|---|
| Front Right | 265/65R17 | 112Q | Goodyear | Wrangler | V | 5218 | 5 mm |

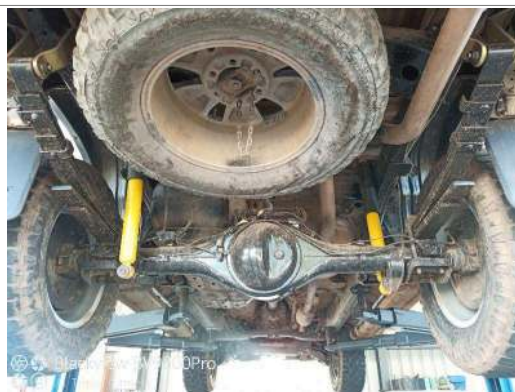
CHASSIS

| Damage | Repair Way |
|---|---|
| Sub Frame Welded | Repair |

| Damage | Repair Way |
|---|---|
| Vehicle is cut and join on sub frame | |

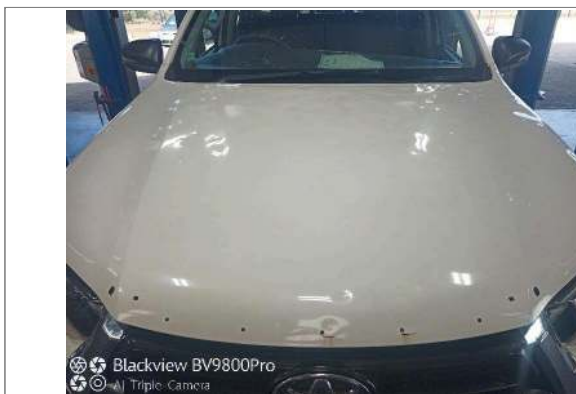
| Damage | Repair Way |
|---|---|
| Bonnet Dented | Repair |

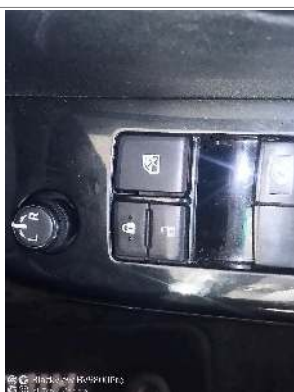
| Damage | Repair Way |
|---|---|
| Central Locking Defective | Repair |
