## CONDITION REPORT

Report No:  
2016927884  
DATE  
27/06/2025

| Manufacturer | TOYOTA | Registration Number | JPG682MP |
| Model | HILUX 2.4 GD-6 RB SRX D-CAB DSL PU [2018-2020] | Register Number | |

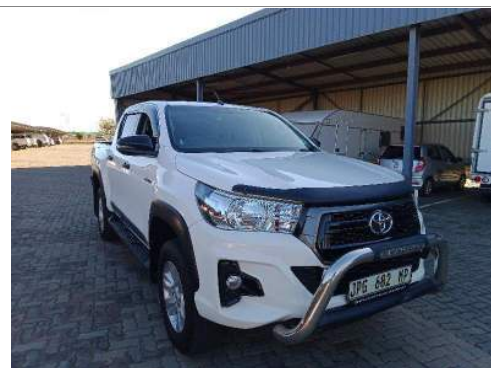
FRONT RIGHT CORNER

| Damage | Repair Way |
|---|---|
| Door Panel Front Right Damaged | Repair |
| Front Bumper Damaged | Repair |

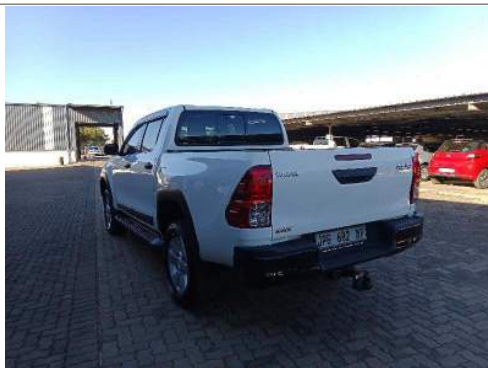
REAR LEFT CORNER

| Damage | Repair Way |
|---|---|
| Rear Fender Left Residual Traces of Repair | Repair |

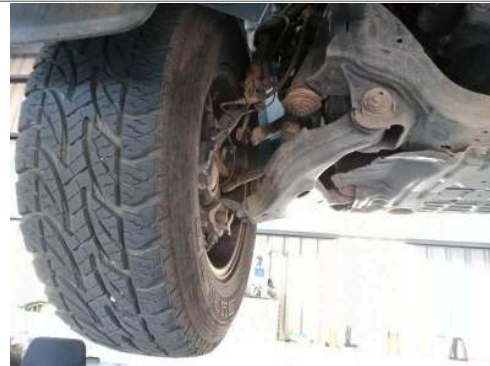
LF TYRE TREAD

| | Size | Load/Speed Index | Manufacture | Model | Type* | Production Date | Tread Depth (mm) |
|---|---|---|---|---|---|---|---|
| Front Left | 265/65 R17 | 112S | Bridgestone | Dueler | V | 0224 | 7 mm |

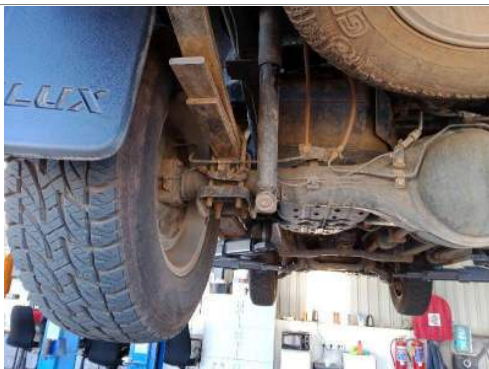
LR TYRE TREAD

| | Size | Load/Speed Index | Manufacture | Model | Type* | Production Date | Tread Depth (mm) |
|---|---|---|---|---|---|---|---|
| Rear Left | 265/65 R17 | 112S | Bridgestone | Dueler | V | 3524 | 8 mm |

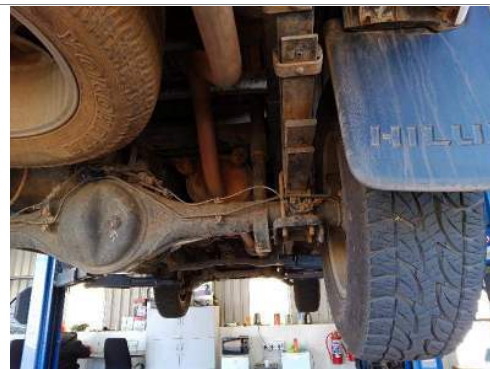
RR TYRE TREAD

| | Size | Load/Speed Index | Manufacture | Model | Type* | Production Date | Tread Depth (mm) |
|---|---|---|---|---|---|---|---|
| Rear Right | 265/65 R17 | 112S | Bridgestone | Dueler | V | 0224 | 7 mm |

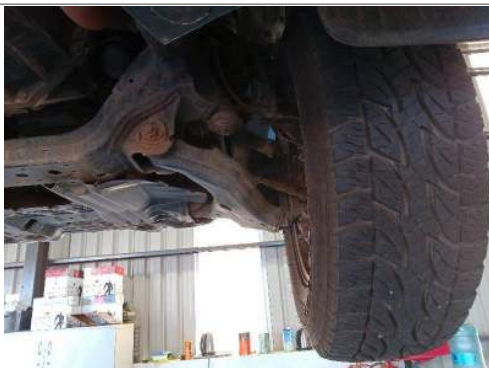
RF TYRE TREAD

| | Size | Load/Speed Index | Manufacture | Model | Type* | Production Date | Tread Depth (mm) |
|---|---|---|---|---|---|---|---|
| Front Right | 265/65 R17 | 112S | Bridgestone | Dueler | V | 0224 | 7 mm |

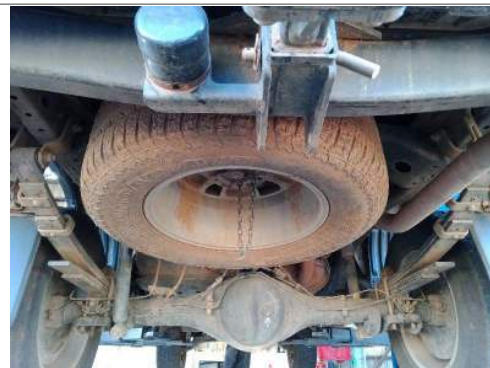
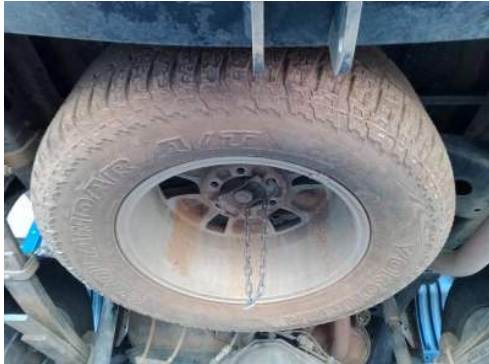
Spare wheel

| | Size | Load/Speed Index | Manufacture | Model | Type* | Production Date | Tread Depth (mm) |
|---|---|---|---|---|---|---|---|
| Spare | 265/65 R17 | 112H | Yokohama | Geolander | V | 0000 | 5 mm |

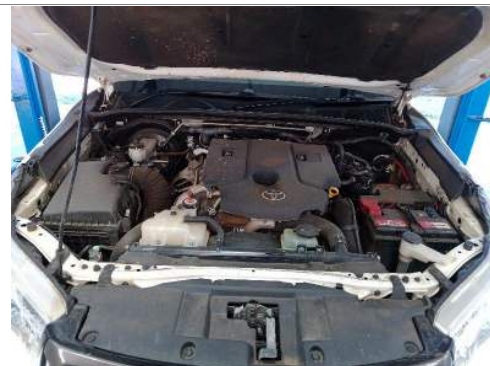
ENGINE 1

| Damage | Repair Way |
|---|---|
| Engine | Engine bay dirty. |

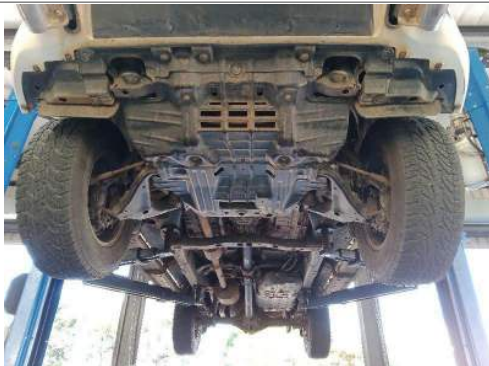
Front chassis

| Damage | Repair Way |
|---|---|
| Axle and suspension | Non standard lift kit fitted to vehicle. |
| Undercarriage | Vehicle undercarriage dirty |

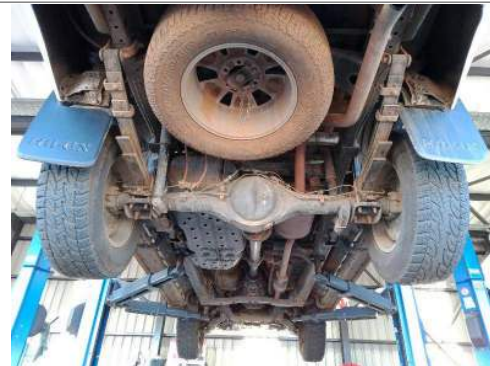
Rear chassis

| Damage | Repair Way |
|---|---|
| Shock Absorber Mounting Rear Right Cracked | Replace |
