## CONDITION REPORT

Report No:  
2016923142  
DATE  
24/06/2025

MFC Auction House  
M57 Pretoria Rd, Glenmarais, KEMPTON PARK  
Gauteng

Vehicle Type	PASSENGER VEHICLE	Registered Owner	MFC AUCTION HOUSE
Manufacturer	TOYOTA	Registration Number	HY82LJGP
Model	COROLLA QUEST 1.6 PLUS [2016-2021]	Register Number	
VIN	AHTLB52E503140432	Date Of First Licensing	
Engine Number		Last COR	
Doors	4	License Expiry Date	31/12/2021
Color	SILVER	Power / Displacement	
Year Model	2019	Paint Finish	M - METALLIC
Km Reading	103,466 KM	Fuel	PETROL
Cab / Body Type	SEDAN	Transmission	MANUAL

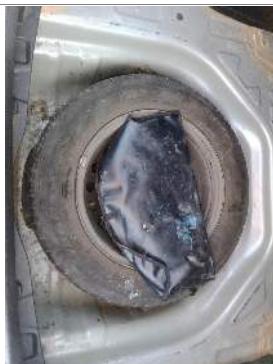
Spare wheel

Size	Load/Speed Index	Manufacture	Model	Type*	Production Date	Tread Depth (mm)
Front Left	195/65R15	91H	Continental	Contact	V	4222	1 mm
Front Right	195/65R15	91H	Continental	Contact	V	4222	1 mm
Rear Left	195/65R15	91H	Goodyear	Excellence	V	4718	2 mm
Rear Right	195/65R15	91H	Crosa 65	Radial	V	4912	3 mm
Spare	195/65R15	91H	Goodyear	Excellence	V	////	2 mm

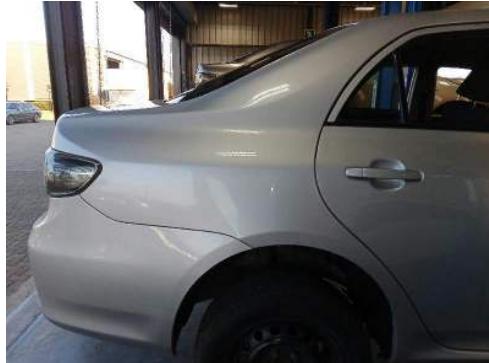
Damage	Repair Way
Headlight Left Damaged	Replace
Gear Lever Dust Boot Defective	Repair
Side Mirror Left Paintwork • Scratched	Repair
Side Mirror Right Paintwork • Scratched	Repair
Front Bumper Paintwork • Scratched	Repair
Bonnet Paintwork • Chipmarks	Repair
Front Fender Left Paintwork • Scratched	Repair
Rear Fender Left Dented	Repair
Rear Fender Right Paintwork • Chipmarks	Repair
Door Front Left Dented	Repair
Door Front Right Paintwork • Scratched	Repair
Door Rear Left Paintwork • Scratched	Repair
Door Rear Right Paintwork • Scratched	Repair
Rear bumper Paintwork • Scratched	Repair
Windscreen Chipped	Repair
Tyre Rear Right Damaged	Replace
Gearbox Oil Leak	Repair
Rear hub cap missing	Replace
R/F fender liner missing	Replace
Rear tires deferred name brand	Repair
