CONDITION REPORT

Report No: 2016206319

MFC Auction House
M57 Pretoria Rd, Glenmarais, KEMPTON PARK
Gauteng

Vehicle Type	PASSENGER VEHICLE	Registered Owner	MFC
Manufacturer	TOYOTA	Registration Number	NN101-678
Model	COROLLA	Register Number	
VIN	AHTLT56E606036635	Date Of First Licensing	
Engine Number		Last COR	
Doors	4	License Expiry Date	30/06/2024
Color	SILVER	Power / Displacement	
Year Model		Paint Finish	M - METALLIC
Km Reading	88,090 KM	Fuel	PETROL
Cab / Body Type	SEDAN	Transmission	MANUAL

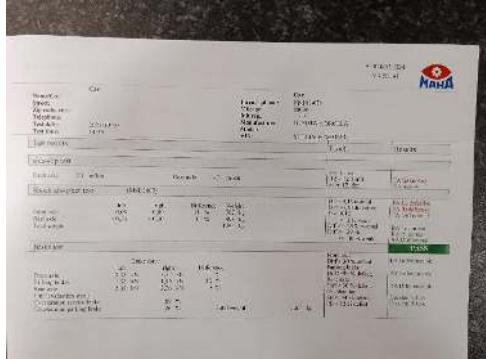
Shock and brake report

Left	Right	Axle Weight [KG]	Deceleration [m/s ²]
	Braking Force [kN]	Braking Force [kN]		
Front	3.3	3.3	-	
Rear	2.0	2.2	-	
Emergency / Parking	1.3	1.9	-

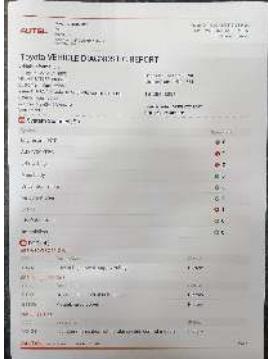
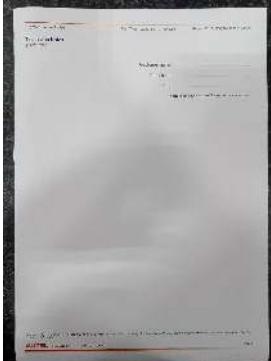
Diagnostic test

During the diagnostic no active error messages were detected. (See also attached Diagnostic Report. For more information regarding the Fault Codes (DTC) and the recommended rectifications please contact the workshops of the vehicle manufacture).

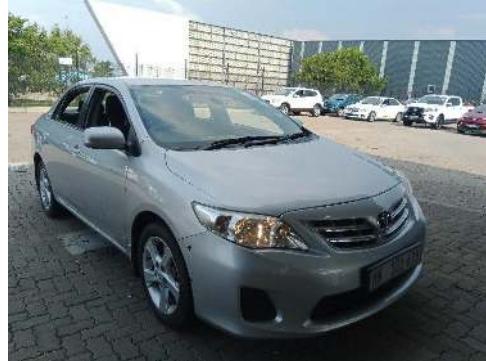
FRONT RIGHT CORNER

Body • Exterior: Minor dents scratches and stone chips on some body panels. Signs of spray work done on some body panels.

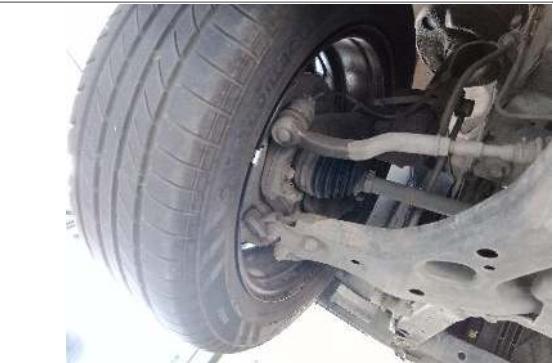
LF TYRE TREAD

Size	Load/Speed Index	Manufacture	Model	Type*	Production Date	Tread Depth (mm)
Front Left	205/55R16	91V	Continental	Contact	V	4418	5 mm
Front Right	205/55R16	91V	Continental	Contact	V	1612	0 mm
Rear Left	205/55R16	91V	Continental	Contact	V	4218	5 mm
Rear Right	205/55R16	91V	Continental	Contact	V	4218	5 mm
Spare	205/55R16	91V	Continental	Contact	V	//////////	0 mm
