MFC Auction House  
M57 Pretoria Rd, Glenmarais, KEMPTON PARK  
Gauteng

Vehicle Type	PASSENGER VEHICLE	Registered Owner	MFC AUCTION HOUSE
Manufacturer	TOYOTA	Registration Number	KG64KXGP
Model	QUANTUM	Register Number	
VIN	AHTSX22PX07036993	Date Of First Licensing	
Engine Number		Last COR	
Doors	4	License Expiry Date	31/03/2024
Color	WHITE	Power / Displacement	
Year Model		Paint Finish	C - COMMON
Km Reading	307,724 KM	Fuel	PETROL
Cab / Body Type	OTHERS	Transmission	MANUAL

## CONDITION REPORT

Report No: 2016355293

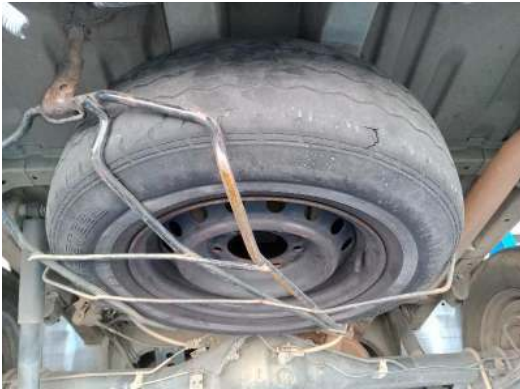
Spare wheel

Damage	Repair Way
Service Brake Performance Rear Axle Left / Right	Repair
Difference out of legal range	
Parking Brake Performance Malfunction	Repair
Tyre Rear Right Smooth	Replace
Spare Tyre Torn / Cut	Replace
Fuel Tank Dented	Replace
Radiator Cradle Welded	Repair
Boot not opening	Repair
Vehicle is cut and join on l/F maine beam	Repair
Airbag light on	Repair
