## CONDITION REPORT

Report No: 2016390243

| Manufacturer | MAZDA | Registration Number | HWB377MP |
| VIN | JM6BL10F2C0309036 | Date Of First Licensing | |

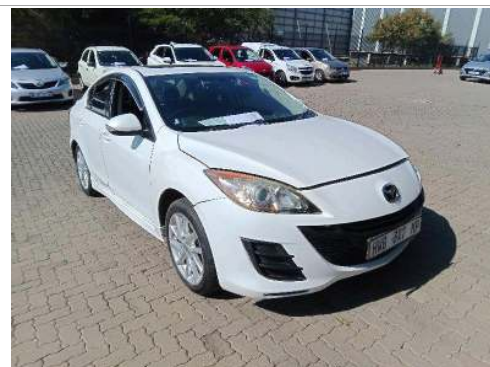
FRONT RIGHT CORNER

| Damage | Repair Way |
|---|---|
| Body and exterior | Signs of impact damage to front of vehicle. |

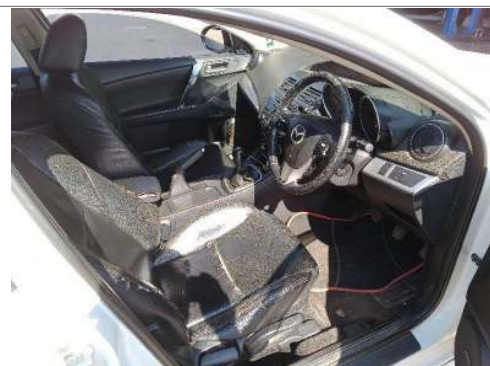
INTERIOR (FRONT DRIVER DOOR)

| Damage | Repair Way |
|---|---|
| interior | Vehicle interior in poor condition. |

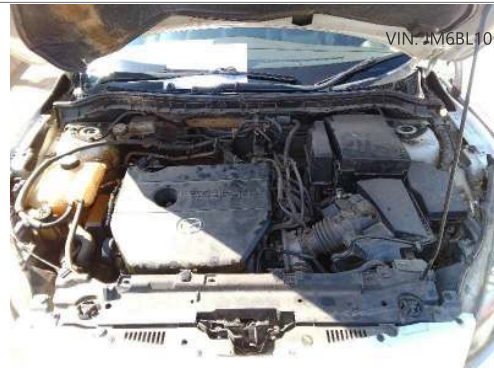
ENGINE 1

| Damage | Repair Way |
|---|---|
| Engine Oil Leak | Repair |
| Engine Wiring Damaged | Repair |
| Fan Belt Worn | Replace |

| Damage | Repair Way |
|---|---|
| Engine | aircon fan belt missing |
| Engine | fan cowl damaged |
