## CONDITION REPORT

Report No: 2016353244

| Manufacturer | MAZDA | Registration Number | JH82BKGP |
| Model | MAZDA 3 | Register Number | |

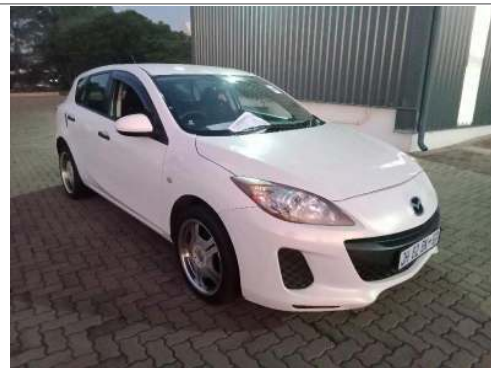
FRONT RIGHT CORNER

| Damage | Repair Way |
|---|---|
| Front Fender Right Dented | Repair |
| Door Front Right Dented | Repair |

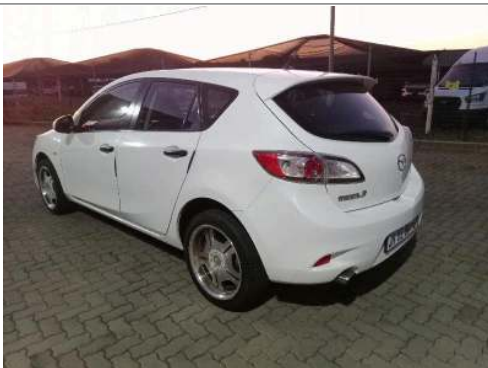
REAR LEFT CORNER

| Damage | Repair Way |
|---|---|
| Rear Fender Left Residual Traces of Repair | Repair |
| Door Rear Left Residual Traces of Repair | Repair |

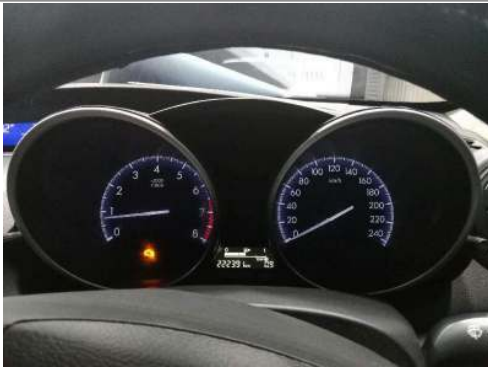
DASHBOARD (W/ ENGINE RUNNING)

| Damage | Repair Way |
|---|---|
| Warning light illuminated on dashboard | Repair |

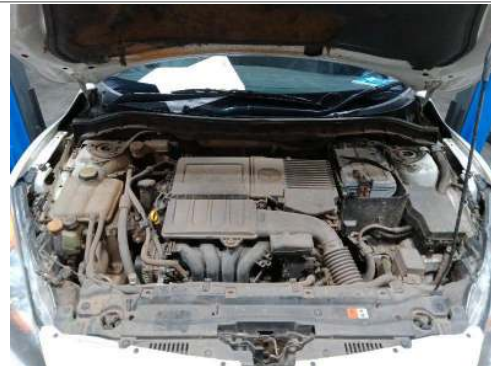
ENGINE 1

| Damage | Repair Way |
|---|---|
| Engine Oil Leak | Repair |

| Damage | Repair Way |
|---|---|
| Engine | Engine bay dirty |

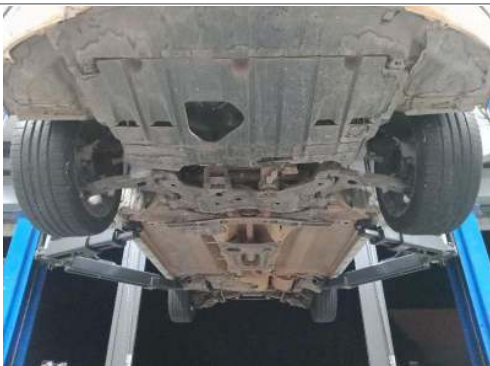
Front chassis

| Damage | Repair Way |
|---|---|
| Chassis Dented | Repair |
| Undercarriage | Signs of surface rust on undercarriage |
