CONDITION REPORT

Report No:
2016899701
DATE
02/06/2025

Vehicle Type	PASSENGER VEHICLE	Registered Owner	
Manufacturer	MITSUBISHI	Registration Number	HZD020MP
Model	ASX 2.0 GLS ROCKFORD CVT [2014-2018]	Register Number	
VIN	JMYXTGA2WFZC00865	Date Of First Licensing	
Engine Number		Last COR	
Doors	5	License Expiry Date	31/01/2026
Color	WHITE	Power / Displacement	
Year Model	2016	Paint Finish	M - METALLIC
Km Reading	83,242 KM	Fuel	PETROL
Cab / Body Type	STATION WAGON	Transmission	AUTOMATIC

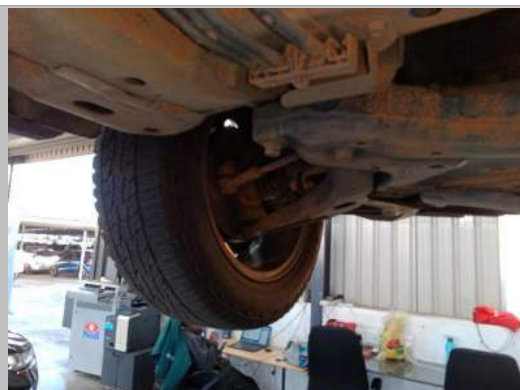
LF TYRE TREAD

Size	Load/Speed Index	Manufacture	Model	Type*	Production Date	Tread Depth (mm)
Front Left	215/60R17	100H	Falken	Wild peak	V	3522	5 mm
Front Right	215/60R17	100H	Falken	Wild peak	V	3522	5 mm
Rear Left	215/60R17	100H	Falken	Wild peak	V	3522	5 mm
Rear Right	215/60R17	100H	Falken	Wild peak	V	3522	5 mm
Spare	215/60R17	96H	Dunlop	Sp sport	V	0000	5 mm
