CONDITION REPORT

Report No: 2016256558

DATE
06/02/2024

| Manufacturer | CHEVROLET | Registration Number | JXB681MP |

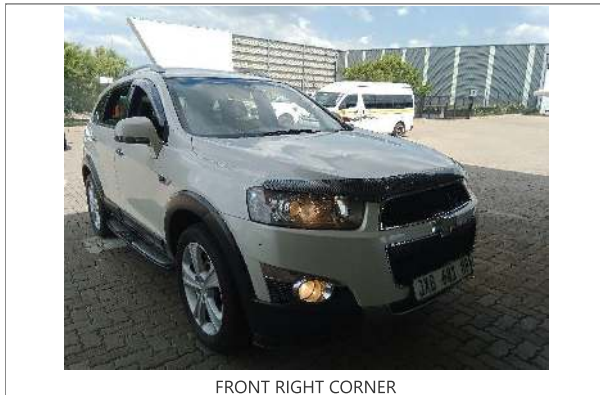
FRONT RIGHT CORNER

| Damage | Repair Way |
|--|---|
| Indicator Light Front Right Broken | Replace |
| Ball Joint(s) Front Axle Right Cracked | Replace |

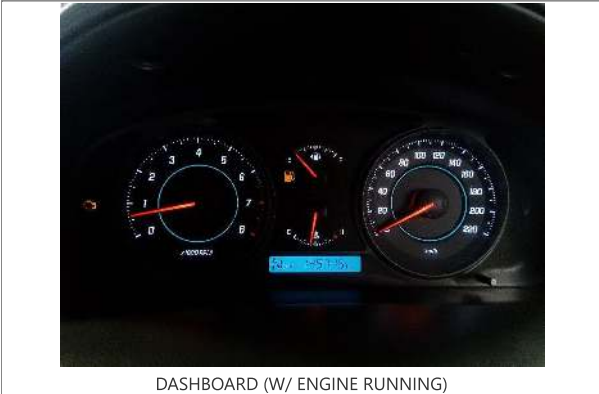
DASHBOARD (W/ ENGINE RUNNING)

| Damage | Repair Way |
|--|---|
| Engine warning light illuminated. | Repair |

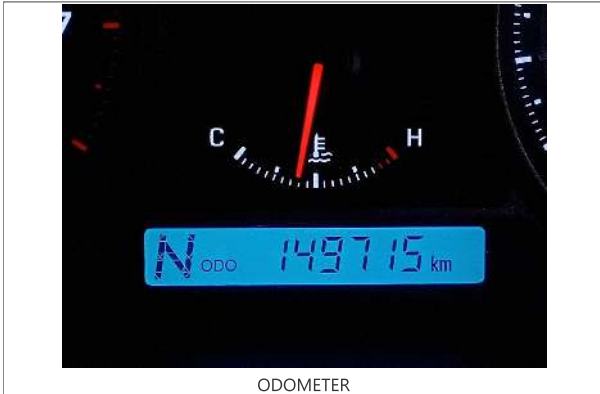
ODOMETER

| Km Reading | 149,715 KM | Fuel | PETROL |

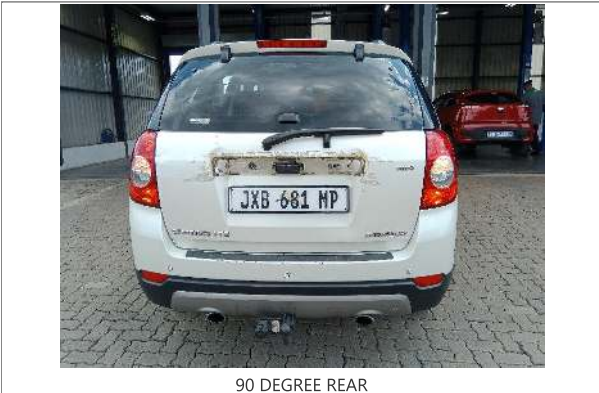
90 DEGREE REAR

| Damage | Repair Way |
|--|---|
| Boot Lid / Hatch door Dented | Repair |

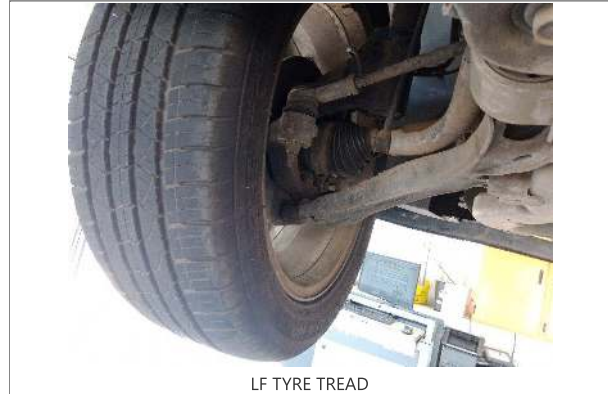
LF TYRE TREAD

| | Size | Load/Speed Index | Manufacture | Model | Type* | Production Date | Tread Depth (mm) |
|---|---|---|---|---|---|---|---|
| Front Left | 235/50R19 | 103W | Ling long | Crosswind | V | 5220 | 5 mm |

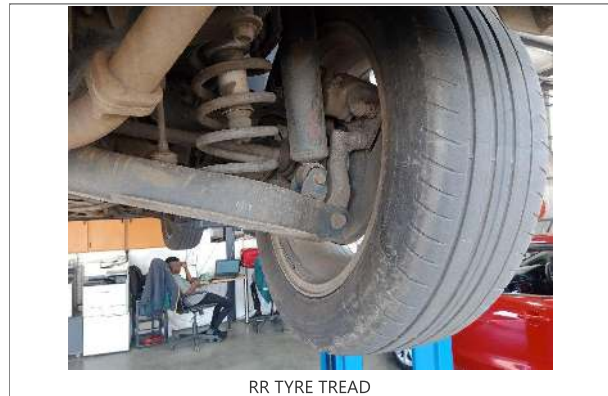
RR TYRE TREAD

| | Size | Load/Speed Index | Manufacture | Model | Type* | Production Date | Tread Depth (mm) |
|---|---|---|---|---|---|---|---|
| Rear Right | 235/50R19 | 99V | Goodyear | Eagle | V | 0421 | 5 mm |

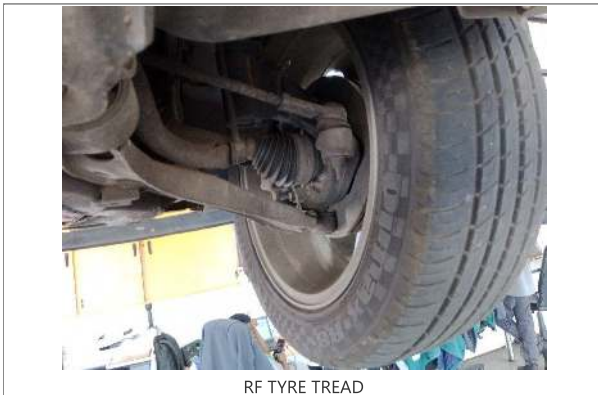
RF TYRE TREAD

| | Size | Load/Speed Index | Manufacture | Model | Type* | Production Date | Tread Depth (mm) |
|---|---|---|---|---|---|---|---|
| Front Right | 235/50R19 | 103W | Radar | Dimax | V | 0000 | 6 mm |

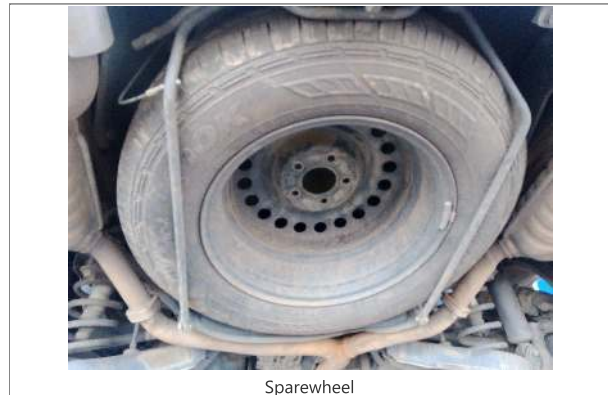
Sparewheel

| | Size | Load/Speed Index | Manufacture | Model | Type* | Production Date | Tread Depth (mm) |
|---|---|---|---|---|---|---|---|
| Spare | 215/70R16 | 100T | Hankook | Dynamic | V | /////// | 5 mm |
