MFC Auction House  
M57 Pretoria Rd, Glenmarais, KEMPTON PARK  
Gauteng

DEKRA MFC  
M57 Pretoria Rd - 1619  
KEMPTON PARK - GT  
08610 33572

| Manufacturer | HYUNDAI | Registration Number | CP67KKGP |
| Model | H-100 BAKKIE 2.6 DECK DSL PU [2011-2020] | Register Number | |

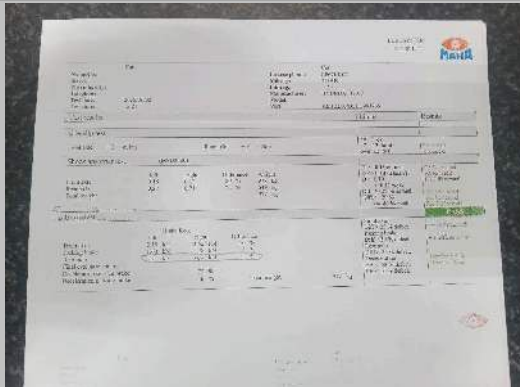
Shock and brake report

| | Left | Right | | |
|---|---|---|---|---|
| Front | 3.1 | 3.5 | - | |
| Rear | 0.0 | 0.0 | - | |
| Emergency / Parking | 1.6 | 1.7 | - | |

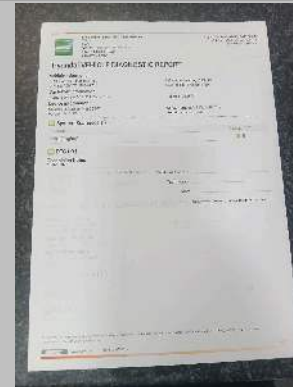
Diagnostic report

During the diagnostic no active error messages were detected. (See also attached Diagnostic Report. For more information regarding the Fault Codes (DTC) and the recommended rectifications please contact the workshops of the vehicle manufacture).

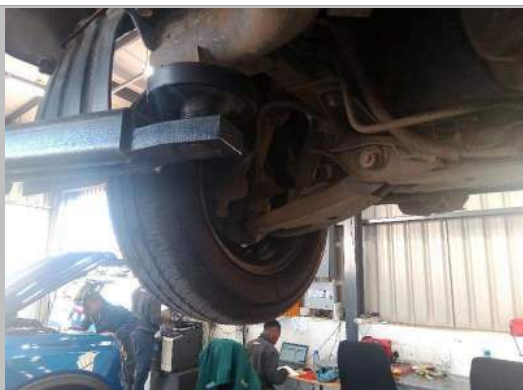
LF TYRE TREAD

| | Size | Load/Speed Index | Manufacture | Model | Type* | Production Date | Tread Depth (mm) |
|---|---|---|---|---|---|---|---|
| Front Left | 195/70R15 | 104/102R | Autogrip | Van max | V | 4324 | 4 mm |

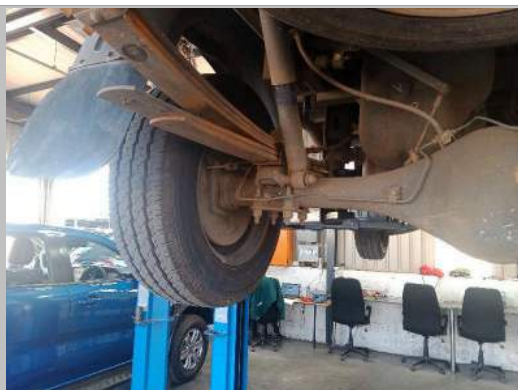
LR TYRE TREAD

| | Size | Load/Speed Index | Manufacture | Model | Type* | Production Date | Tread Depth (mm) |
|---|---|---|---|---|---|---|---|
| Rear Left | 195/70R15 | 104/102R | Autogrip | Van max | V | 4324 | 4 mm |

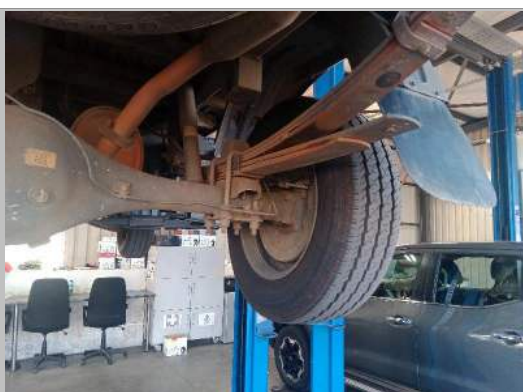
RR TYRE TREAD

| | Size | Load/Speed Index | Manufacture | Model | Type* | Production Date | Tread Depth (mm) |
|---|---|---|---|---|---|---|---|
| Rear Right | 195/70R15 | 104/102R | Autogrip | Van max | V | 4324 | 4 mm |

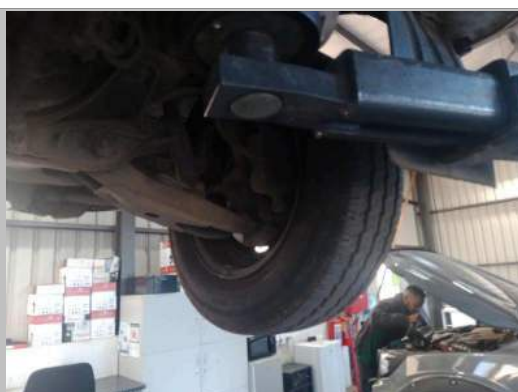
RF TYRE TREAD

| | Size | Load/Speed Index | Manufacture | Model | Type* | Production Date | Tread Depth (mm) |
|---|---|---|---|---|---|---|---|
| Front Right | 195/70R15 | 104/102R | Autogrip | Van max | V | 4324 | 4 mm |

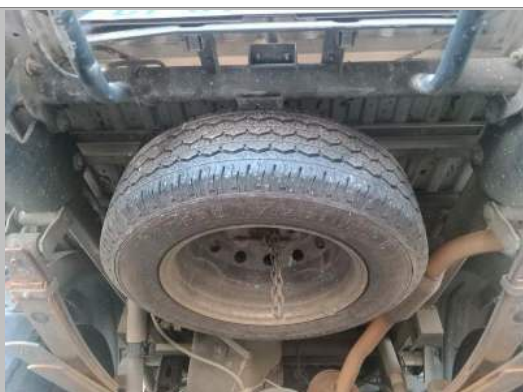
Spare wheel

| | Size | Load/Speed Index | Manufacture | Model | Type* | Production Date | Tread Depth (mm) |
|---|---|---|---|---|---|---|---|
| Spare | 195/70R15 | 104/102R | Good ride | Radial h188 | V | 0000 | 4 mm |
