MFC Auction House  
M57 Pretoria Rd, Glenmarais, KEMPTON PARK  
Gauteng

| Manufacturer | HYUNDAI | Registration Number | HK72YPGP |

## CONDITION REPORT

Report No: 2016660424

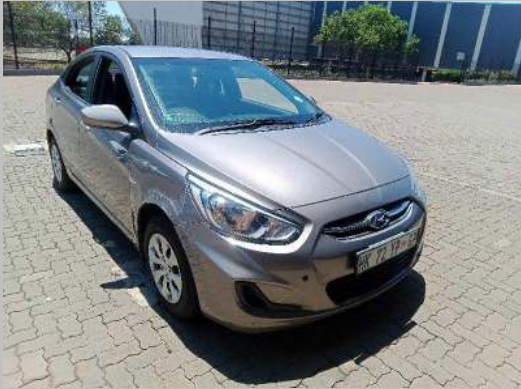
FRONT RIGHT CORNER

| Damage | Repair Way |
|---|---|
| Front Fender Right Damaged | Repair |

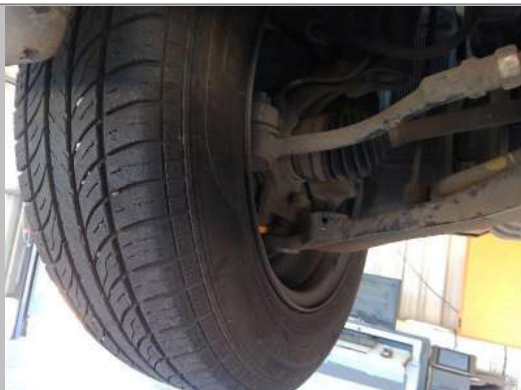
LF TYRE TREAD

| | Size | Load/Speed Index | Manufacture | Model | Type* | Production Date | Tread Depth (mm) |
|---|---|---|---|---|---|---|---|
| Front Left | 175/70R14 | 84T | Rovelo | RHL | V | 3821 | 4 mm |

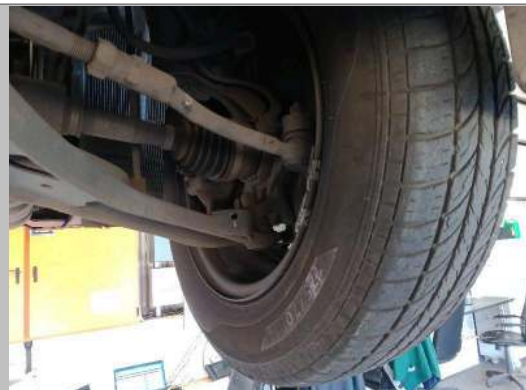
RF TYRE TREAD

| | Size | Load/Speed Index | Manufacture | Model | Type* | Production Date | Tread Depth (mm) |
|---|---|---|---|---|---|---|---|
| Front Right | 175/70R14 | 84T | Rovelo | RHP | V | 3821 | 4 mm |

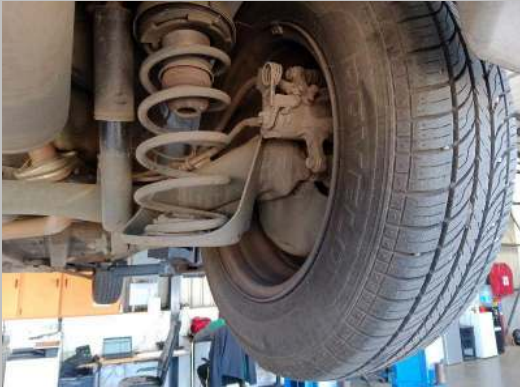
RR TYRE TREAD

| | Size | Load/Speed Index | Manufacture | Model | Type* | Production Date | Tread Depth (mm) |
|---|---|---|---|---|---|---|---|
| Rear Right | 175/70R14 | 84T | Kumho | Solus | V | 0000 | 5 mm |

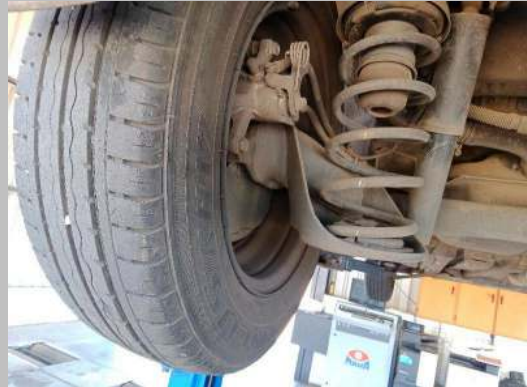
LR TYRE TREAD

| | Size | Load/Speed Index | Manufacture | Model | Type* | Production Date | Tread Depth (mm) |
|---|---|---|---|---|---|---|---|
| Rear Left | 175/70R14 | 84T | Kumho | Solus | V | 0000 | 3 mm |
