## CONDITION REPORT

Report No: 2016204863

MFC Auction House  
M57 Pretoria Rd, Glenmarais, KEMPTON PARK  
Gauteng

| Manufacturer | HYUNDAI | Registration Number | JB43GXGP |

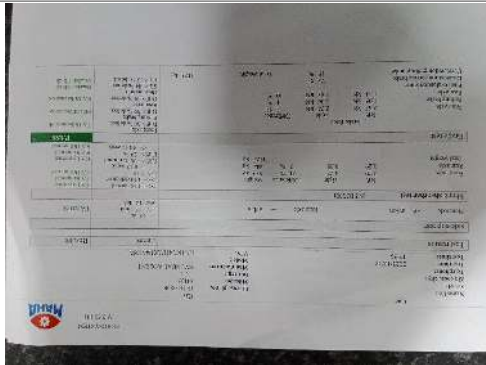
Shock and brake

| Damage | Repair Way |
|---|---|
| Shock Absorber Rear Right Sweat | Replace |

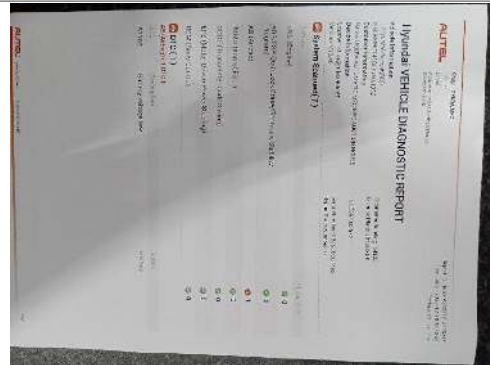
During the diagnostic no active error messages were detected. (See also attached Diagnostic Report. For more information regarding the Fault Codes (DTC) and the recommended rectifications please contact the workshops of the vehicle manufacture).

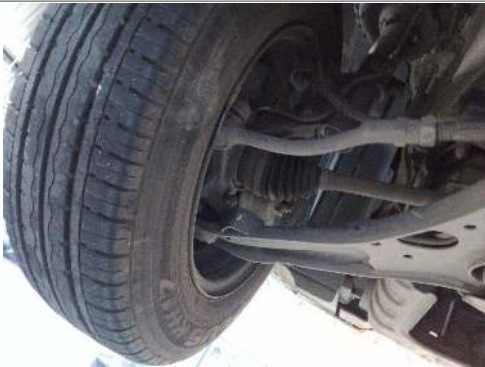
LF TYRE TREAD

| | Size | Load/Speed Index | Manufacture | Model | Type* | Production Date | Tread Depth (mm) |
|---|---|---|---|---|---|---|---|
| Front Left | 175/70R14 | 84T | Kumho | Solus | V | 1517 | 6 mm |

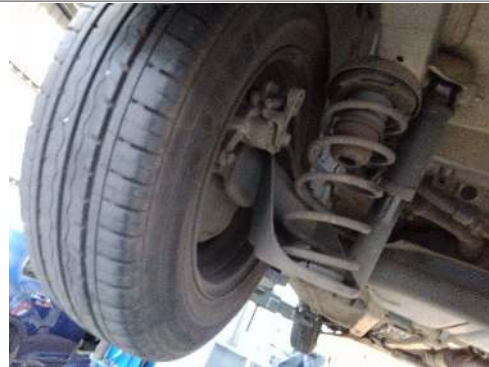
LR TYRE TREAD

| | Size | Load/Speed Index | Manufacture | Model | Type* | Production Date | Tread Depth (mm) |
|---|---|---|---|---|---|---|---|
| Rear Left | 175/70R14 | 84T | Kumho | Solus | V | 4218 | 5 mm |

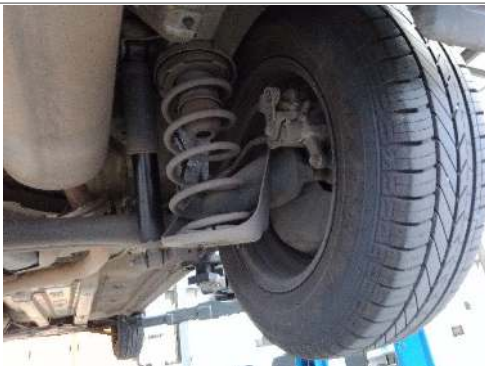
RR TYRE TREAD

| | Size | Load/Speed Index | Manufacture | Model | Type* | Production Date | Tread Depth (mm) |
|---|---|---|---|---|---|---|---|
| Rear Right | 175/70R14 | 84T | Goodyear | Duraplus | V | 4920 | 7 mm |
