MFC Auction House
M57 Pretoria Rd, Glenmarais, KEMPTON PARK
Gauteng

Vehicle Type	PASSENGER VEHICLE	Registered Owner	
Manufacturer	HYUNDAI	Registration Number	JYK223MP
Model	ELANTRA	Register Number	
VIN	KMHD041BVJU748685	Date Of First Licensing	
Engine Number		Last COR	
Doors	4	License Expiry Date	
Color	WHITE	Power / Displacement	
Year Model		Paint Finish	TWO COAT UNI
Km Reading	160,570 KM	Fuel	PETROL
Cab / Body Type	SEDAN	Transmission	AUTOMATIC

VEHICLE INSPECTION

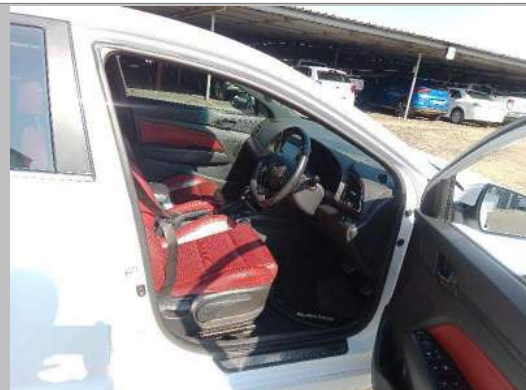
INTERIOR (FRONT DRIVER DOOR)

Damage	Repair Way
Engine Oil Leak	Repair
Seat Front Right Torn / Cut	Repair
Door Panel Front Right Defective	Repair
Steering Wheel Trim Defective	Repair
Front Bumper Residual Traces of Repair	Repair
Bonnet Paintwork • Chipmarks	Repair
Front Fender Left Dented	Repair
Rear Fender Left Dented	Repair
Rear Fender Right Paintwork • Scratched	Repair
Front Fender Left / Inner Tray Defective	Repair
Rear Fender Right / Inner Tray Damaged	Repair
Door Front Left Paintwork • Scratched	Repair
Door Front Right Paintwork • Scratched	Repair
Door Rear Left Dented	Repair
Door Rear Right Paintwork • Scratched	Repair
Boot Lid / Hatch door Residual Traces of Repair	Repair
Rear bumper Paintwork • Scratched	Repair
Inner Boot Floor Pan and Spare Wheel Well Paintwork • Scratched	Repair
Sill Panel Left Damaged	Repair
Sill Panel Right Residual Traces of Repair	Repair
Windscreen Cracked	Replace
Tyre Rear Left Damaged	Replace
Rim Front Left Dented	Repair

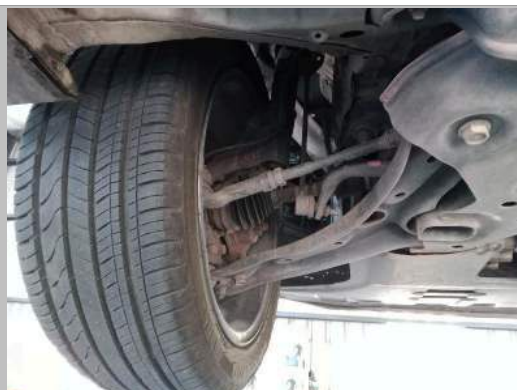
LF TYRE TREAD

Size	Load/Speed Index	Manufacture	Model	Type*	Production Date	Tread Depth (mm)
Front Left	225/45Z R17	94W	Hilo	Vantage	V	0125	6 mm
Front Right	225/45Z R17	94W	Hilo	Vantage	V	0125	6 mm
Rear Left	225/45 R17	91W	Hankook	Ventus	V	0221	0 mm
Rear Right	225/45 R17	91W	Dunlop	Sp-Sport	V	0617	1 mm
Spare	T125/80 R16	97M	Hankook	Temporary		2518	1 mm
