## CONDITION REPORT

Report No:  
2016903489  
DATE  
05/06/2025

| Manufacturer | HYUNDAI | Registration Number | FWX543MP |
| Model | IX35 2.0 EXECUTIVE [2010-2013] | Register Number | |

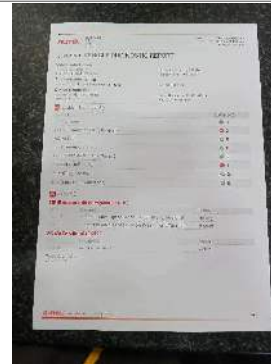
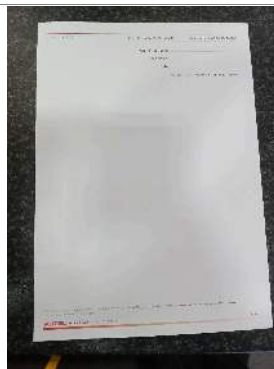
Diagnostic report

| No | System | Code | Description | Status |
|---|---|---|---|---|
| 1 | ACTIVE | B1688 | A/C IONIZER FAULT | |

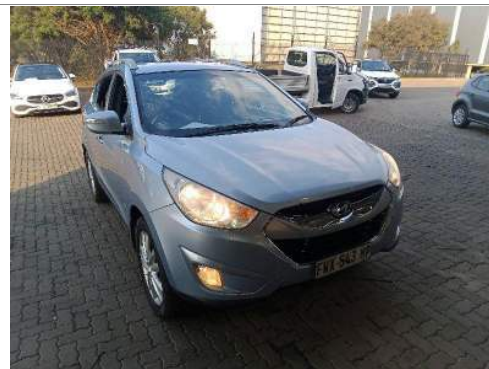
FRONT RIGHT CORNER

| Damage | Repair Way |
|---|---|
| Front Fender Right Paintwork • Scratched | Repair |

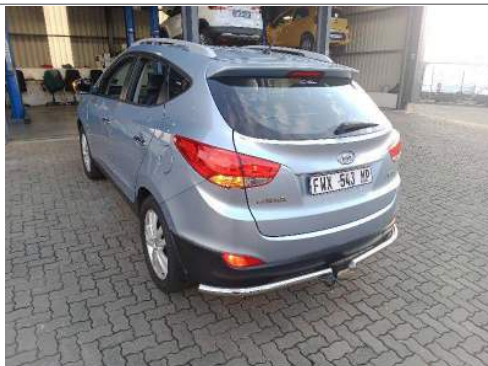
REAR LEFT CORNER

| Damage | Repair Way |
|---|---|
| Rear Fender Left Dented | Repair |
| Rear Fender Right Paintwork • Scratched | Repair |

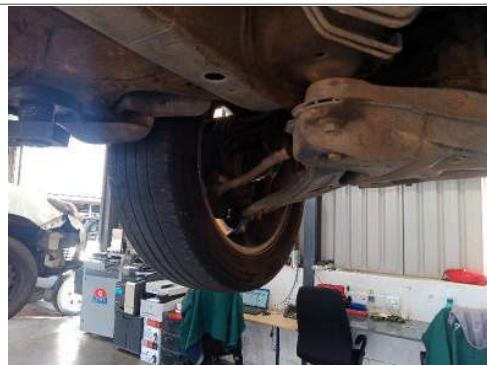
LF TYRE TREAD

| | Size | Load/Speed Index | Manufacture | Model | Type* | Production Date | Tread Depth (mm) |
|---|---|---|---|---|---|---|---|
| Front Left | 225/55R18 | 98H | Lanvigator | Performax | V | 1621 | 4 mm |

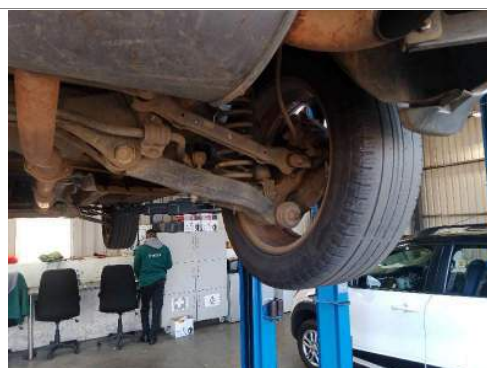
RR TYRE TREAD

| | Size | Load/Speed Index | Manufacture | Model | Type* | Production Date | Tread Depth (mm) |
|---|---|---|---|---|---|---|---|
| Rear Right | 225/55R18 | 98V | Goodyear | Efficient gr | V | 4319 | 3 mm |

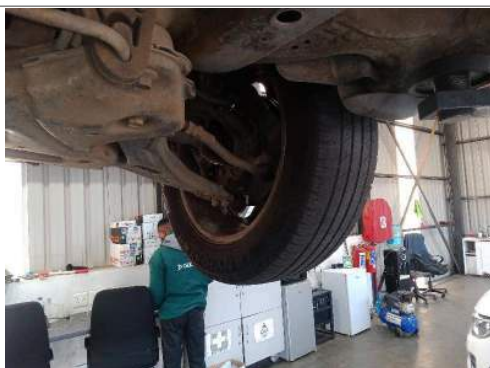
RF TYRE TREAD

| Damage | Repair Way |
|---|---|
| Front tires deferred name brand from rear tires | Repair |

| | Size | Load/Speed Index | Manufacture | Model | Type* | Production Date | Tread Depth (mm) |
|---|---|---|---|---|---|---|---|
| Front Right | 225/55R18 | 98H | Lanvigator | Performax | V | 1121 | 3 mm |

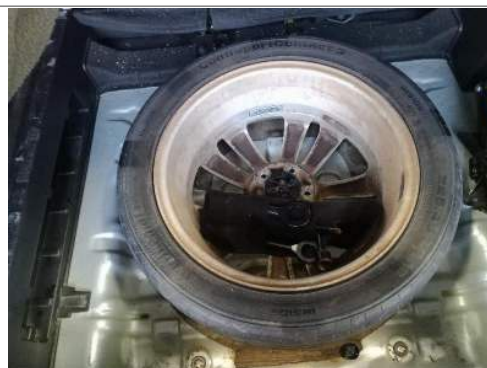
Spare wheel

| | Size | Load/Speed Index | Manufacture | Model | Type* | Production Date | Tread Depth (mm) |
|---|---|---|---|---|---|---|---|
| Spare | 225/45R18 | 95W | Continental | Contact | V | 0000 | 2 mm |
