## CONDITION REPORT

Report No: 2016395143

MFC Auction House  
M57 Pretoria Rd, Glenmarais, KEMPTON PARK  
Gauteng

Vehicle Type	PASSENGER VEHICLE	Registered Owner	MFC AUCTION HOUSE
Manufacturer	HYUNDAI	Registration Number	FGT291L
Model	H-1	Register Number	
VIN	KMHWH81KMGU801461	Date Of First Licensing	
Engine Number		Last COR	
Doors	5	License Expiry Date	31/12/2024
Color	WHITE	Power / Displacement	
Year Model		Paint Finish	C - COMMON
Km Reading	264,302 KM	Fuel	DIESEL
Cab / Body Type	OTHERS	Transmission	AUTOMATIC

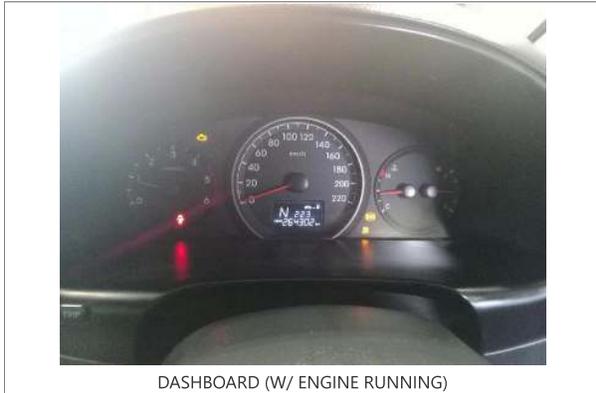
DASHBOARD (W/ ENGINE RUNNING)

Body exterior	Signs of spray work done on some body panels
Body exterior	Minor dents scratches and stone chips on some body
Warning lights illuminated.	Repair.
Axle and suspension	Excessive noise front suspension

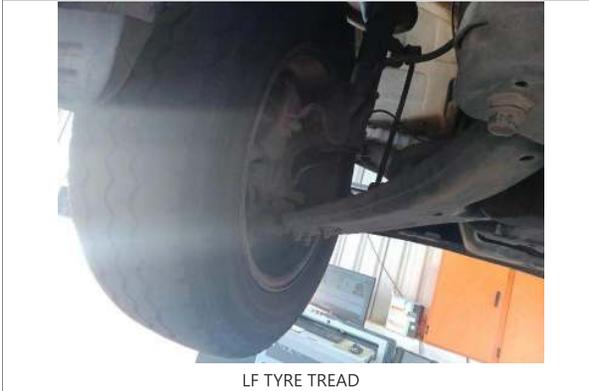
LF TYRE TREAD

Size	Load/Speed Index	Manufacture	Model	Type*	Production Date	Tread Depth (mm)
Front Left	215/65R16	109/107R	Grenlander	L-max		0119	1 mm
Front Right	215/65R16	109/107R	Grenlander	L-max	V	0119	1 mm
Rear Left	215/70R16	99T	Lanvigator	Catchfors	V	1321	0 mm
Rear Right	215/65R16	98H	Continental	Contact	V	4018	1 mm
Spare	195/75R16	107/105	Michelin	Aglis	V	///////	1 mm

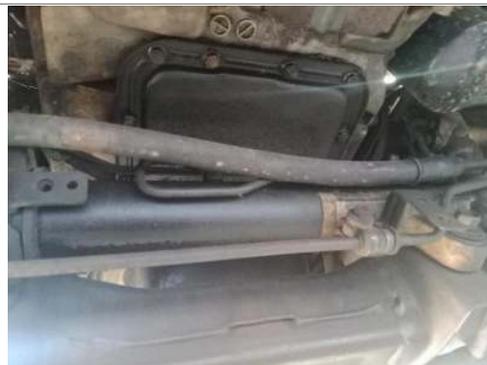
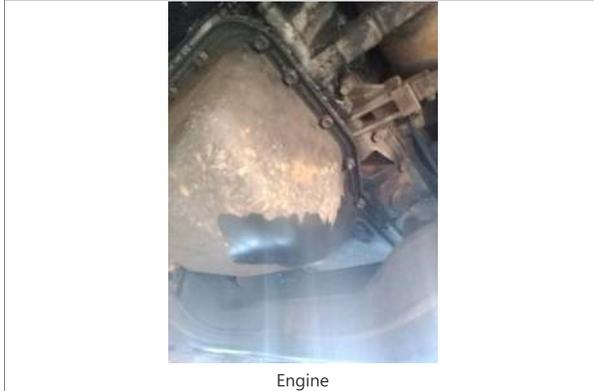
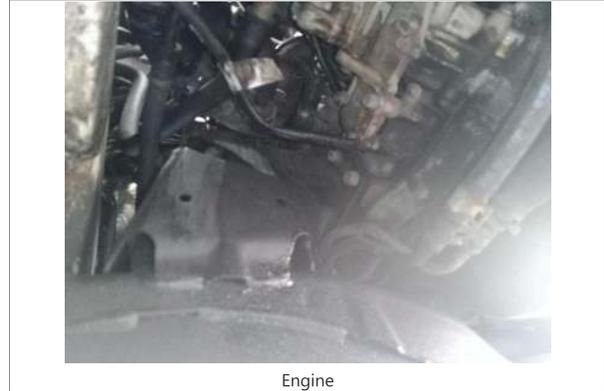
Damage	Repair Way
Engine Oil Leak	Repair
Engine Wiring Defective	Repair
Windscreen Wiper Malfunction	Replace
Park Light Rear Right Defective	Repair
Fog Light Front Left Missing	Replace
Fog Light Front Right Defective	Replace
Seat Front Right Excessive Wear & Tear	Repair
Seat Rear Torn / Cut	Repair
Door Handle Rear Right Damaged	Replace
Channel / Roof Gutter Left Damaged	Repair
Front Bumper Residual Traces of Repair	Repair
Grill Damaged	Replace
Bonnet Paintwork • Flaking	Repair
Front Fender Left Residual Traces of Repair	Repair
Rear Fender Right Residual Traces of Repair	Repair
Door Front Left Residual Traces of Repair	Repair
Sill Panel Right Damaged	Repair
Sliding Door Dented	Repair
Windscreen Cracked	Replace
Shock Absorber Rear Right Leak	Replace
Tyre Rear Left Smooth	Replace
Bolt(s) / Nut(s) Front Wheel Left Missing	Replace
Catalytic converter Welded	Replace
Axle and suspension.	Both front control arm bushes covered
