| Manufacturer | KIA | Registration Number | FJ90WWGP |
| Model | PICANTO 1.0 LX 5-DR [2011-2018] | Register Number | |

## CONDITION REPORT

Report No: 2016674532

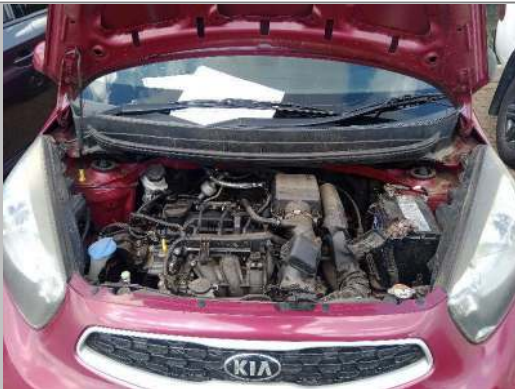
ENGINE 1

General Comments: ACCORDING TO AGE AND MILEAGE OF VEHICLE NORMAL WEAR AND TEAR ON INTERIOR, EXTERIOR, ELECTRICAL AND MECHANICAL PARTS.Engine Compartment: excessive oil leak.

| Damage | Repair Way |
|---|---|
| Engine Oil Leak | Replace |
