MFC Auction House  
M57 Pretoria Rd, Glenmarais, KEMPTON PARK  
Gauteng

| Manufacturer | KIA | Registration Number | JV91HRGP |

## CONDITION REPORT

Report No: 2016439572

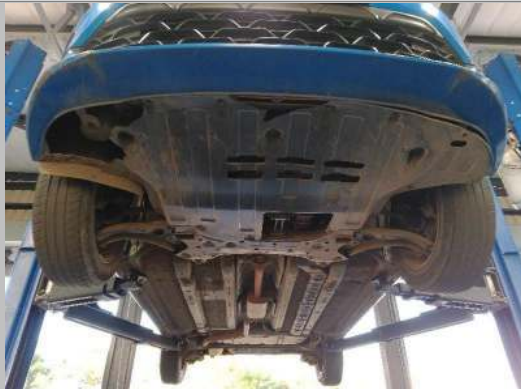
Front chassis

| Damage | Repair Way |
|---|---|
| Chassis Damaged | Repair |

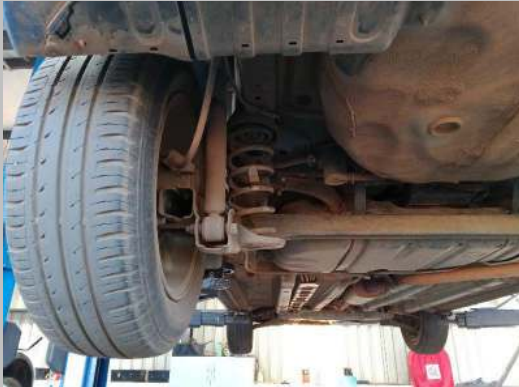
LR TYRE TREAD

| | Size | Load/Speed Index | Manufacture | Model | Type* | Production Date | Tread Depth (mm) |
|---|---|---|---|---|---|---|---|
| Rear Left | 185/65 R15 | 88T | Continental | ContiEco | V | 3109 | 4 mm |

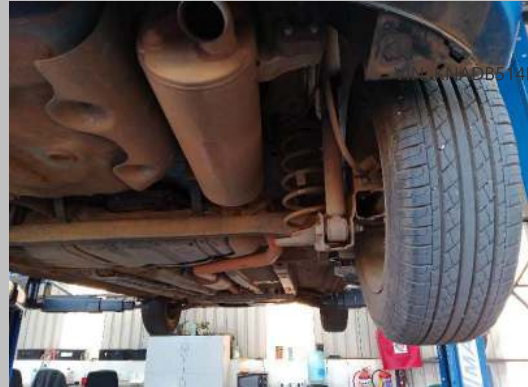
RR TYRE TREAD

| Damage | Repair Way |
|---|---|
| Tyre Rear Right Defective | Replace |

| | Size | Load/Speed Index | Manufacture | Model | Type* | Production Date | Tread Depth (mm) |
|---|---|---|---|---|---|---|---|
| Rear Right | 185/65 R15 | 88H | Champro | GT Radial | V | 2521 | 5 mm |

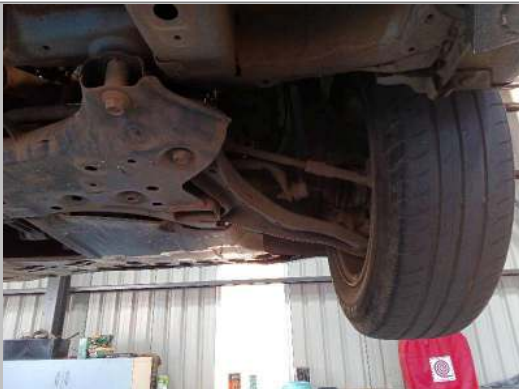
RF TYRE TREAD

| Damage | Repair Way |
|---|---|
| Tyre Front Right Defective | Replace |

| | Size | Load/Speed Index | Manufacture | Model | Type* | Production Date | Tread Depth (mm) |
|---|---|---|---|---|---|---|---|
| Front Right | 185/65 R15 | 88H | Nexen | Nblue | V | 1420 | 3 mm |

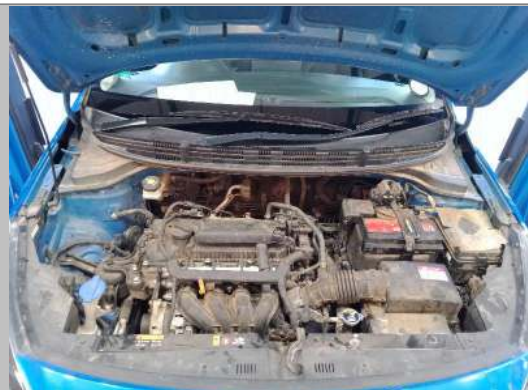
ENGINE 1

| Damage | Repair Way |
|---|---|
| Engine | Signs of rodent in engine bay |
| Engine | Engine bay dirty |
