MFC Auction House
M57 Pretoria Rd, Glenmarais, KEMPTON PARK
Gauteng

Vehicle Type	PASSENGER VEHICLE	Registered Owner	MFC
Manufacturer	KIA	Registration Number	KP27VKGP
Model	RIO	Register Number	
VIN	KNADB518LN6634242	Date Of First Licensing	
Engine Number		Last COR	
Doors	5	License Expiry Date	31/10/2023
Color	SILVER	Power / Displacement	
Year Model		Paint Finish	TWO COAT METALLIC
Km Reading	51,173 KM	Fuel	PETROL
Cab / Body Type	HATCHBACK	Transmission	MANUAL

CONDITION REPORT

Report No: 2016213100

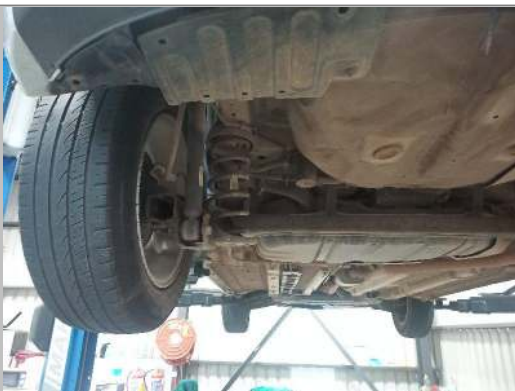
LR TYRE TREAD

Size	Load/Speed Index	Manufacture	Model	Type*	Production Date	Tread Depth (mm)
Front Left	185/65R15	88H	Nexen	Radial	V	4521	0 mm
Front Right	185/65R15	88H	Nexen	Radial	V	4521	1 mm
Rear Left	185/65R15	88H	Autogrip	Radial	V	1523	4 mm
Rear Right	185/65R15	88H	Autogrip	Radial	V	2122	2 mm
