CONDITION REPORT

Report No:
2017002557
DATE
04/09/2025

| Manufacturer | KIA | Registration Number | FS90MHGP |
| Model | RIO 1.4 TEC AT [2015-2017] | Register Number | |

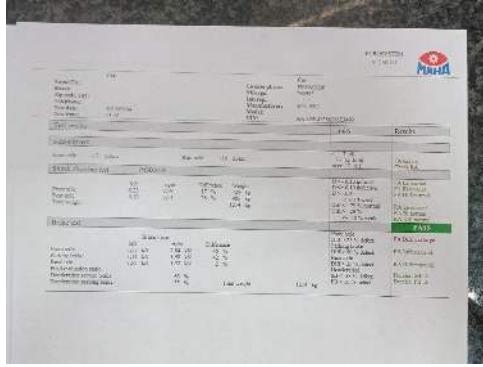
Shock and brake report

| | Left | Right | Axle Weight [KG] | Deceleration [m/s ²] |
|---|---|---|---|---|
| Front | 1.5 | 2.8 | - | |
| Rear | 1.5 | 1.9 | - | |
| Emergency / Parking | 1.1 | 1.9 | - | |

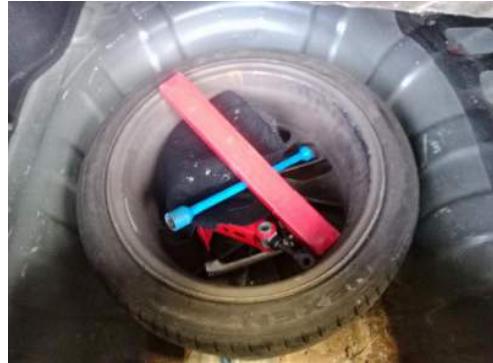
Sparewheel

| | Size | Load/Speed Index | Manufacture | Model | Type* | Production Date | Tread Depth (mm) |
|---|---|---|---|---|---|---|---|
| Spare | 205/40R17 | 84W | Nexen | Nfera | V | | 6 mm |

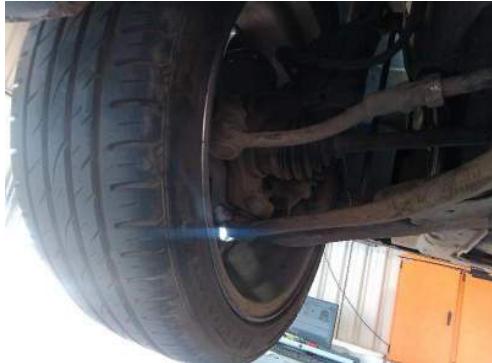
LF TYRE TREAD

| | Size | Load/Speed Index | Manufacture | Model | Type* | Production Date | Tread Depth (mm) |
|---|---|---|---|---|---|---|---|
| Front Left | 205/40R17 | 84W | Nexen | Nfera | V | 0224 | 5 mm |

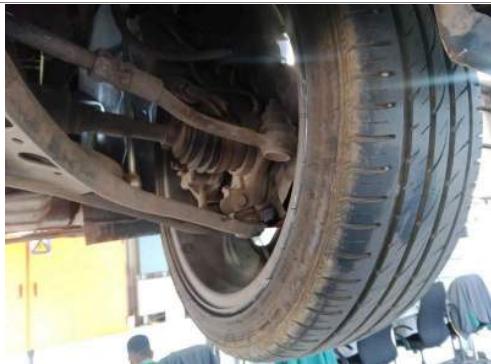
RF TYRE TREAD

| | Size | Load/Speed Index | Manufacture | Model | Type* | Production Date | Tread Depth (mm) |
|---|---|---|---|---|---|---|---|
| Front Right | 205/40R17 | 84W | Nexen | Nfera | V | 4424 | 6 mm |
