## CONDITION REPORT

Report No: 2016223346

MFC Auction House  
M57 Pretoria Rd, Glenmarais, KEMPTON PARK  
Gauteng

| Manufacturer | KIA | Registration Number | FP30KZGP |

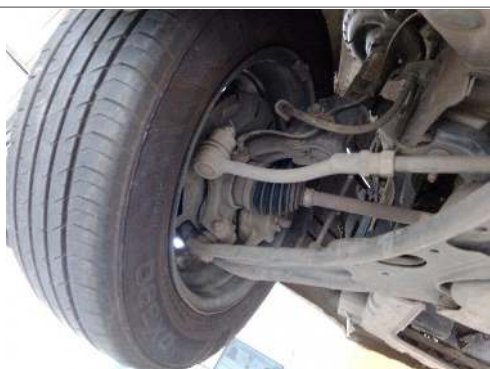
LF TYRE TREAD

| | Size | Load/Speed Index | Manufacture | Model | Type* | Production Date | Tread Depth (mm) |
|---|---|---|---|---|---|---|---|
| Front Left | 185/65R15 | 88H | Davanti | DX390 | V | 2123 | 5 mm |

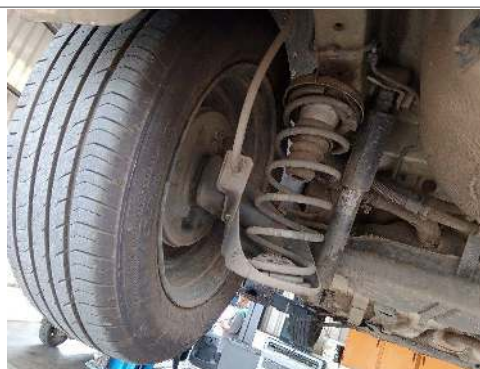
LR TYRE TREAD

| | Size | Load/Speed Index | Manufacture | Model | Type* | Production Date | Tread Depth (mm) |
|---|---|---|---|---|---|---|---|
| Rear Left | 185/65R15 | 88H | Davanti | DX390 | V | 2123 | 5 mm |

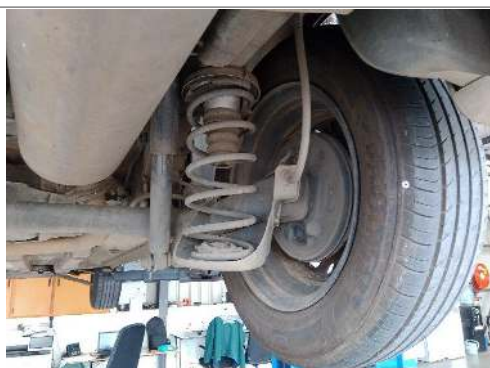
RR TYRE TREAD

| | Size | Load/Speed Index | Manufacture | Model | Type* | Production Date | Tread Depth (mm) |
|---|---|---|---|---|---|---|---|
| Rear Right | 185/65R15 | 88H | Davanti | DX390 | V | 2123 | 5 mm |
