## CONDITION REPORT

Report No: 2016191495

| Manufacturer | KIA | Registration Number | FV93JYGP |
| Model | RIO | Register Number | |

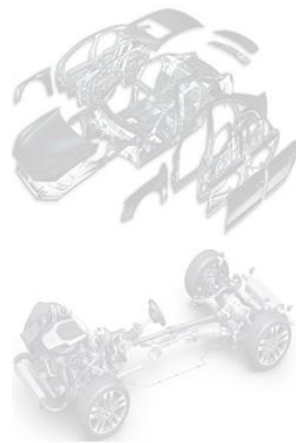
## VEHICLE INSPECTION

| Damage | Repair Way |
|---|---|
| Front Bumper Paintwork • Scratched | Repair |
| Rear Fender Left Paintwork • Scratched | Repair |
| Door Front Left Paintwork • Discoloured | Repair |
| Door Front Right Paintwork • Discoloured | Repair |
| Rear bumper Paintwork • Scratched | Repair |
| Sill Panel Left Paintwork • Scratched | Repair |
