MFC Auction House
M57 Pretoria Rd, Glenmarais, KEMPTON PARK
Gauteng

CONDITION REPORT

Report No: 2016212157

DATE
27/12/2023

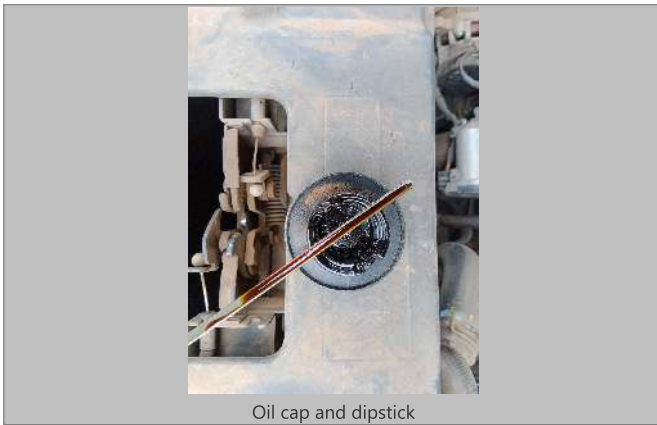
Oil cap and dipstick

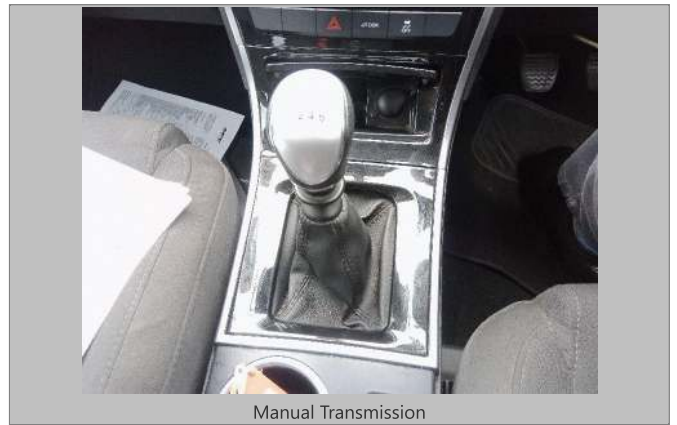
Manual Transmission

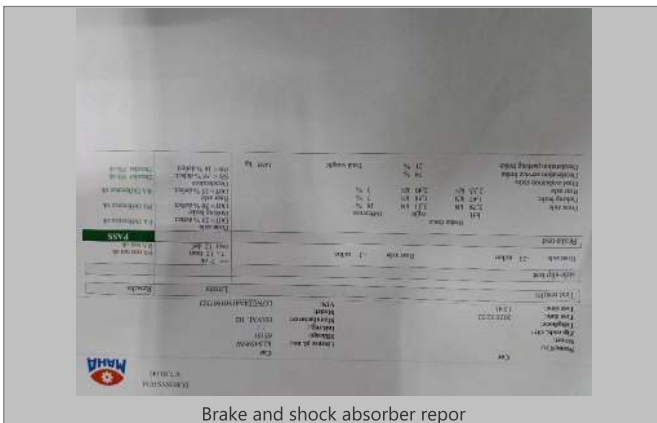
Left	Right	Axle Weight [KG]	Deceleration [m/s ²]
	Braking Force [KN]	Braking Force [KN]		
Front	2.78	3.31	-	
Rear	2.33	2.4	-	
Emergency / Parking	1.47	1.58	-

Brake and shock absorber report

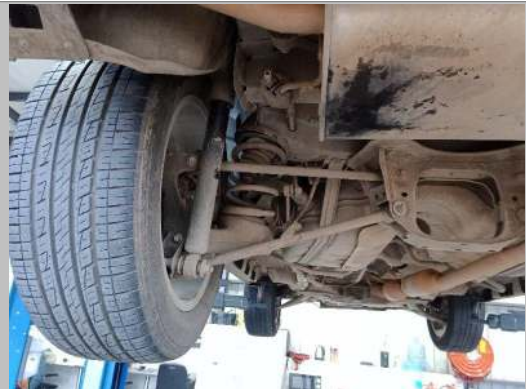
LR TYRE TREAD

Size	Load/Speed Index	Manufacture	Model	Type*	Production Date	Tread Depth (mm)
Front Left	235/55 R18	100V	Blackhawk	Street-H	V	4922	1 mm
Front Right	235/55 R18	100V	Blackhawk	Street-H	V	4922	2 mm
Rear Left	235/55 R18	100H	Kumho	Solus	V	3920	3 mm
Rear Right	235/55 R18	100H	Kumho	Solus	V	3820	4 mm
Spare	T155/85 R18	115M	Chaoyang	Temporary	V	4120	3 mm
