## CONDITION REPORT

Report No:  
2016976331  
DATE  
12/08/2025

| Manufacturer | HAVAL | Registration Number | LK76BHGP |
| Model | JOLION 1.5T LUXURY [2021-2024] | Register Number | |

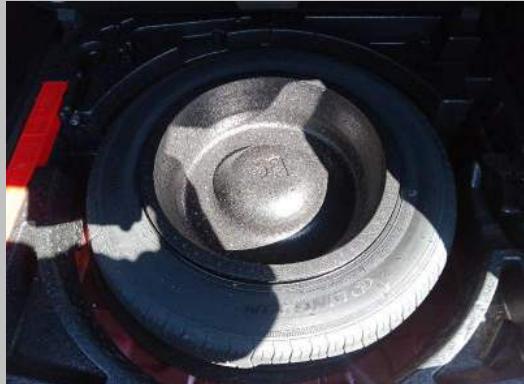
Spare wheel

| | Size | Load/Speed Index | Manufacture | Model | Type* | Production Date | Tread Depth (mm) |
|---|---|---|---|---|---|---|---|
| Spare | T135/90R17 | 104M | Ling long | Temporary | V | //// | 3 mm |

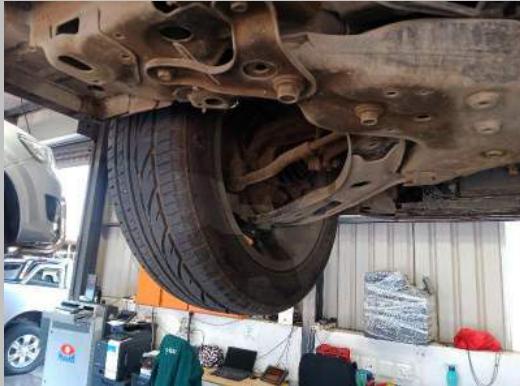
LF TYRE TREAD

| | Size | Load/Speed Index | Manufacture | Model | Type* | Production Date | Tread Depth (mm) |
|---|---|---|---|---|---|---|---|
| Front Left | 225/55R18 | 102Y | Radar | RPX -800 | V | 4323 | 3 mm |

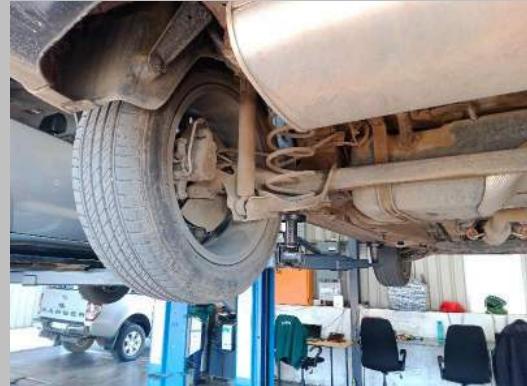
LR TYRE TREAD

| | Size | Load/Speed Index | Manufacture | Model | Type* | Production Date | Tread Depth (mm) |
|---|---|---|---|---|---|---|---|
| Rear Left | 225/55R18 | 98V | Kumho | Solus | V | 4422 | 3 mm |

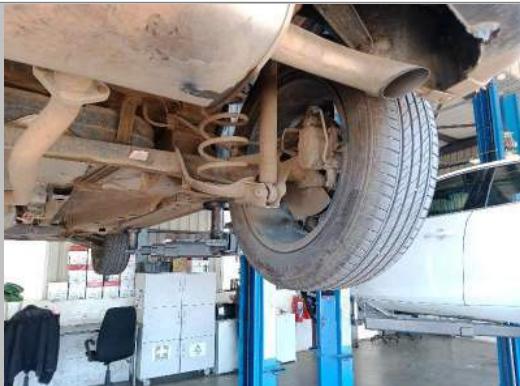
RR TYRE TREAD

| | Size | Load/Speed Index | Manufacture | Model | Type* | Production Date | Tread Depth (mm) |
|---|---|---|---|---|---|---|---|
| Rear Right | 225/55R18 | 98V | Kumho | Solus | V | 4422 | 3 mm |

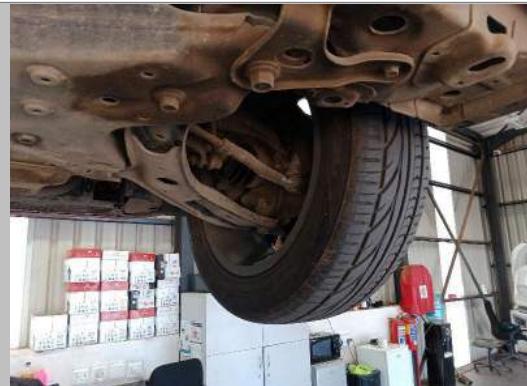
RF TYRE TREAD

| | Size | Load/Speed Index | Manufacture | Model | Type* | Production Date | Tread Depth (mm) |
|---|---|---|---|---|---|---|---|
| Front Right | 225/55R18 | 102Y | Radar | RPX -800 | V | 4223 | 3 mm |
