CONDITION REPORT

Report No: 2016211794

MFC Auction House  
M57 Pretoria Rd, Glenmarais, KEMPTON PARK  
Gauteng

| Manufacturer | CHERY | Registration Number | KVX883MP |

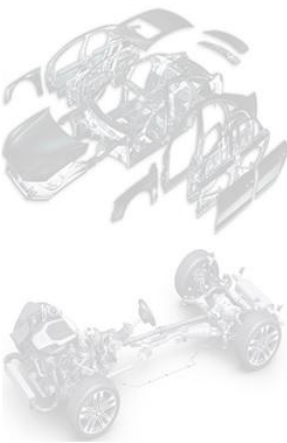
| Damage | Repair Way |
|---|---|
| Front Bumper Damaged | Repair |
| Front Fender Left Damaged | Repair |
| Door Front Left Damaged | Repair |
| Door Front Right Damaged | Repair |
| Door Rear Left Damaged | Repair |
| Door Rear Right Damaged | Repair |
| Rear bumper Damaged | Repair |

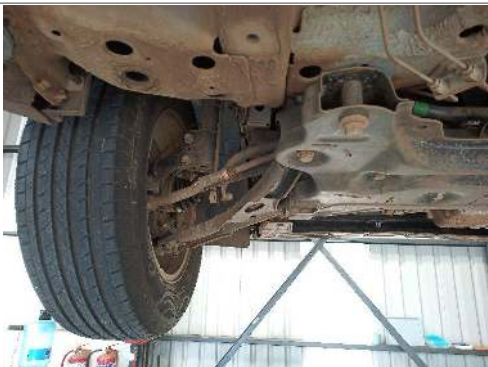
LF TYRE TREAD

| | Size | Load/Speed Index | Manufacture | Model | Type* | Production Date | Tread Depth (mm) |
|---|---|---|---|---|---|---|---|
| Front Left | 215/65R16 | 98H | Linglong | Radial | V | 4622 | 4 mm |

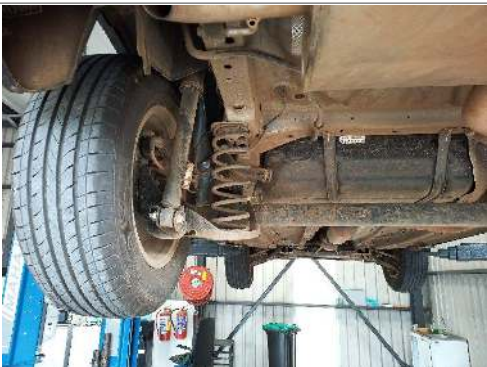
LR TYRE TREAD

| | Size | Load/Speed Index | Manufacture | Model | Type* | Production Date | Tread Depth (mm) |
|---|---|---|---|---|---|---|---|
| Rear Left | 215/65R16 | 98H | Linglong | Radial | V | 4622 | 4 mm |

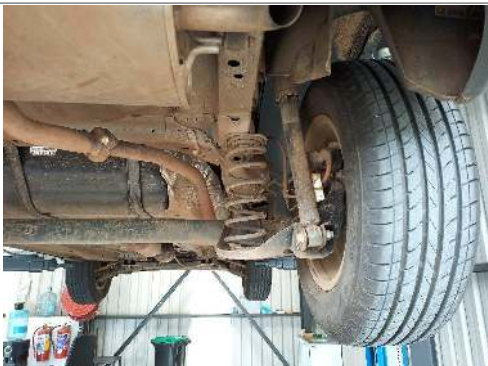
RR TYRE TREAD

| | Size | Load/Speed Index | Manufacture | Model | Type* | Production Date | Tread Depth (mm) |
|---|---|---|---|---|---|---|---|
| Rear Right | 215/65R16 | 98H | Linglong | Radial | V | 4822 | 4 mm |

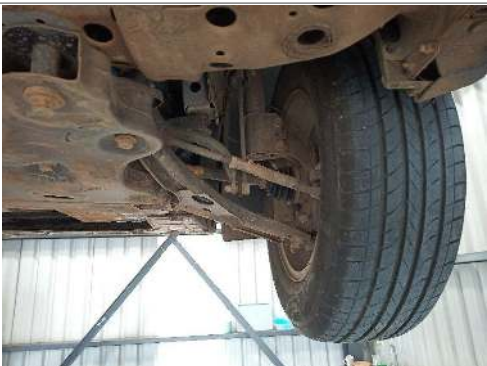
RF TYRE TREAD

| | Size | Load/Speed Index | Manufacture | Model | Type* | Production Date | Tread Depth (mm) |
|---|---|---|---|---|---|---|---|
| Front Right | 215/65R16 | 98H | Linglong | Radial | V | 4722 | 4 mm |
