CONDITION REPORT

Report No:
2016999436
DATE
02/09/2025

Vehicle Type	PASSENGER VEHICLE	Registered Owner	MFC
Manufacturer	SUZUKI	Registration Number	KW27VJGP
Model	CELERIO	Register Number	
VIN	MA3KFC42S00516139	Date Of First Licensing	
Engine Number		Last COR	
Doors	5	License Expiry Date	31/10/2023
Color	SILVER	Power / Displacement	
Year Model		Paint Finish	TWO COAT METALLIC
Km Reading	121,148 KM	Fuel	PETROL
Cab / Body Type	HATCHBACK	Transmission	MANUAL

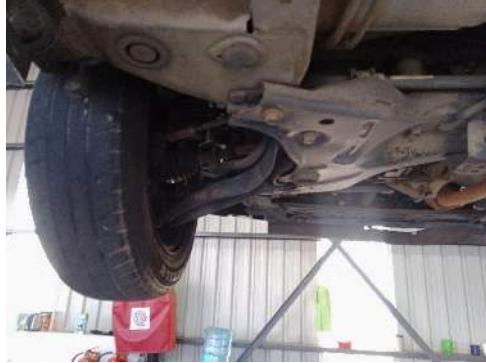
LF TYRE TREAD

Size	Load/Speed Index	Manufacture	Model	Type*	Production Date	Tread Depth (mm)
Front Left	175/65R14	82T	General	Radial	V	3120	0 mm
Front Right	165/70R14	81S	Bridgestone	Radial	V	1218	1 mm
Rear Left	175/70R14	84H	Seamtyer	Radial	V	4419	0 mm
Rear Right	175/70R14	84H	Maxxis	Radial	V	0620	0 mm

Damage	Repair Way
Engine Oil Leak	Repair
Engine Wiring Damaged	Repair
Radio/CD/USB Damaged	Repair
Tail Light Right Damaged	Replace
Headlight Left Damaged	Repair
Seat Front Right Damaged	Repair
Window Winder front right Damaged	Replace
Carpet Front Damaged	Repair
Steering Wheel Trim Damaged	Repair
Side Mirror Left Damaged	Replace
Front Bumper Damaged	Repair
Bonnet Damaged	Repair
Front Fender Left Damaged	Repair
Front Fender Right Damaged	Repair
Rear Fender Left Damaged	Repair
Rear Fender Right Damaged	Repair
Door Front Left Damaged	Repair
Door Front Right Damaged	Repair
Door Rear Left Damaged	Repair
Door Rear Right Damaged	Repair
Boot Lid / Hatch door Damaged	Repair
Rear bumper Damaged	Repair
Windscreen Damaged	Replace
Brake disc 1. Axle left Worn	Replace
Parking Brake Performance Left / Right Difference out of legal range	Repair
Tyre Front Left Worn	Replace
Tyre Rear Left Worn	Replace
Tyre Rear Right Worn	Replace
Gearbox Oil Leak	Repair

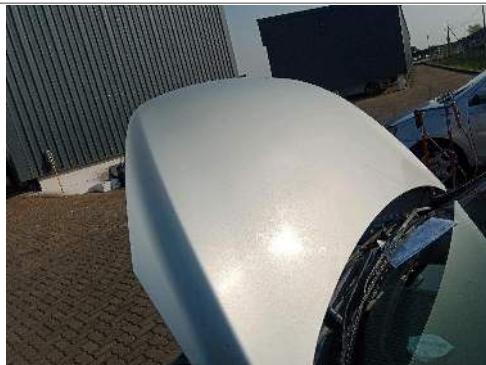
Bonnet

Body • Exterior: Minor dents and scratches and stone chips to some body panels. Signs of repair work done to somebody panels. Poor alignment to somebody panels.
