CONDITION REPORT

Report No: 2016231716

Vehicle Type	PASSENGER VEHICLE	Registered Owner	MFC AUCTION HOUSE
Manufacturer	HYUNDAI	Registration Number	HJ97VWGP
Model	GRAND I10	Register Number	
VIN	MALA851AMJM771836	Date Of First Licensing	
Engine Number		Last COR	
Doors	5	License Expiry Date	31/08/2024
Color	WHITE	Power / Displacement	
Year Model		Paint Finish	C - COMMON
Km Reading	154,564 KM	Fuel	PETROL
Cab / Body Type	HATCHBACK	Transmission	AUTOMATIC

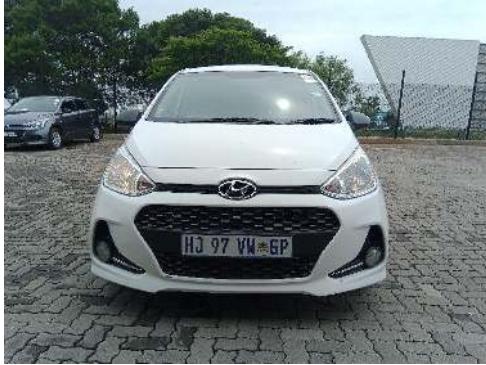
90 DEGREE FRONT

Damage	Repair Way
Dim Light Left Defective	Repair
Fog Light Front Left Defective	Repair
Fog Light Front Right Defective	Repair
Front Bumper Paintwork • Scratched	Repair
Roof Dented	Repair
Gearbox Oil Leak	Repair
Radiator Cradle Damaged	Replace
