MFC Auction House  
M57 Pretoria Rd, Glenmarais, KEMPTON PARK  
Gauteng

## CONDITION REPORT

Report No: 2016377847

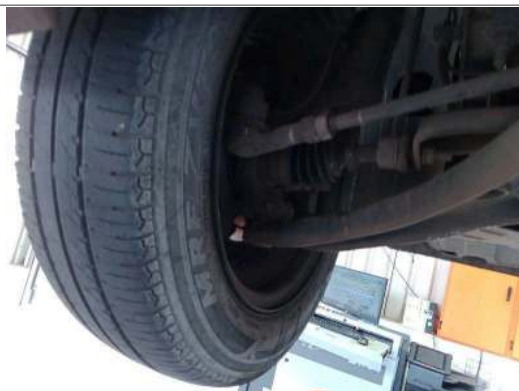
LF TYRE TREAD

| | Size | Load/Speed Index | Manufacture | Model | Type* | Production Date | Tread Depth (mm) |
|---|---|---|---|---|---|---|---|
| Front Left | 165/70R14 | 81T | MRF | ZVTV | V | 0421 | 3 mm |

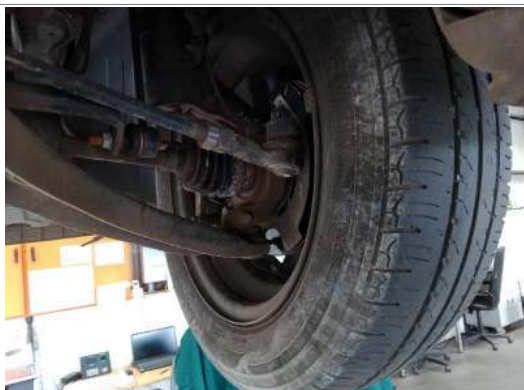
RF TYRE TREAD

| | Size | Load/Speed Index | Manufacture | Model | Type* | Production Date | Tread Depth (mm) |
|---|---|---|---|---|---|---|---|
| Front Right | 165/70R14 | 81T | MRF | ZVTV | V | 0421 | 2 mm |

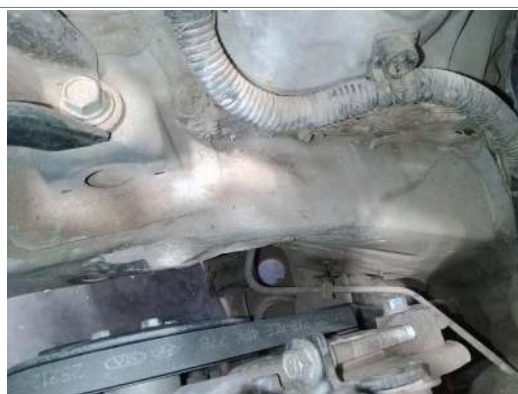
| Damage | Repair Way |
|---|---|
| Main Beam Right Residual Traces of Repair | Repair |
| Signs of cut and joint on main beams | Replace. |
