CONDITION REPORT

Report No: 2016867824

| Manufacturer | HYUNDAI | Registration Number | KL18YJGP |
| Model | ATOS 1.1 50KW MOTION 5-DR AMT [2021-2024] | Register Number | |

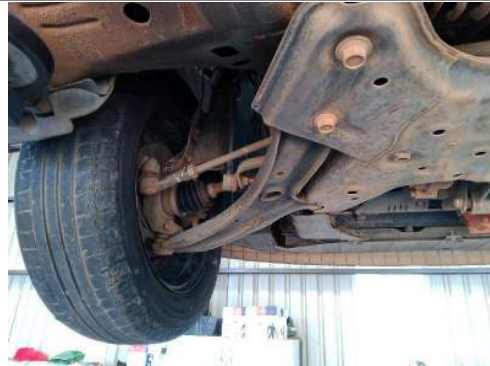
LF TYRE TREAD

| Damage | Repair Way |
|---|---|
| Tyre Front Left Damaged | Replace |

| | Size | Load/Speed Index | Manufacture | Model | Type* | Production Date | Tread Depth (mm) |
|---|---|---|---|---|---|---|---|
| Front Left | 185/60 R14 | 82H | Habilead | Comfort | V | 0113 | 0 mm |

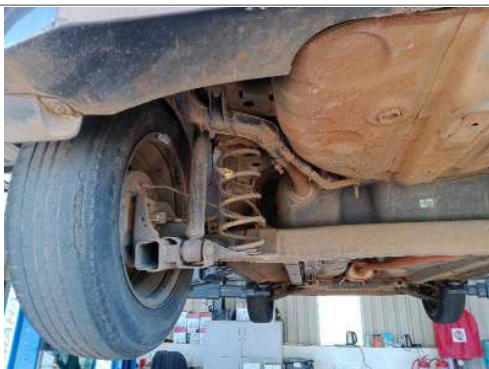
LR TYRE TREAD

| Damage | Repair Way |
|---|---|
| Tyre Rear Left Damaged | Replace |

| | Size | Load/Speed Index | Manufacture | Model | Type* | Production Date | Tread Depth (mm) |
|---|---|---|---|---|---|---|---|
| Rear Left | 175/70 R14 | 84T | Winrun | R330 | V | 2323 | 0 mm |

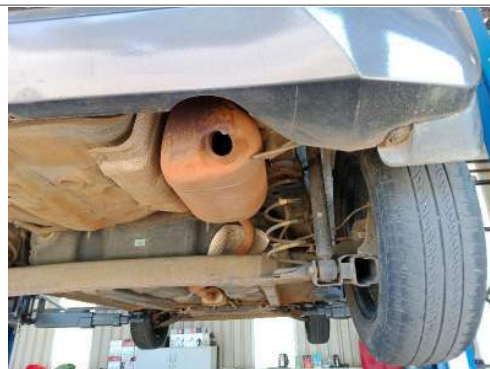
RR TYRE TREAD

| Damage | Repair Way |
|---|---|
| Tyre Rear Right Damaged | Replace |

| | Size | Load/Speed Index | Manufacture | Model | Type* | Production Date | Tread Depth (mm) |
|---|---|---|---|---|---|---|---|
| Rear Right | 175/65 R14 | 82H | Joyroad | Tour | V | 1422 | 0 mm |

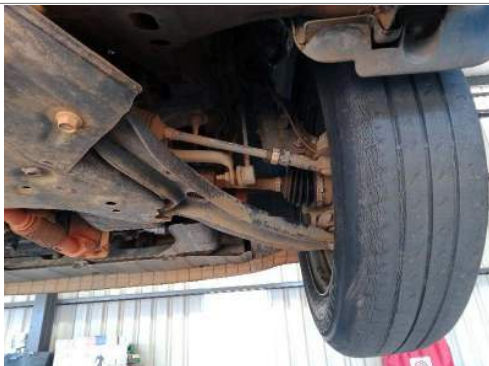
RF TYRE TREAD

| Damage | Repair Way |
|---|---|
| Tyre Front Right Worn | Replace |

| | Size | Load/Speed Index | Manufacture | Model | Type* | Production Date | Tread Depth (mm) |
|---|---|---|---|---|---|---|---|
| Front Right | 175/65 R14 | 82T | Silverstone | Radial | V | 5117 | 0 mm |

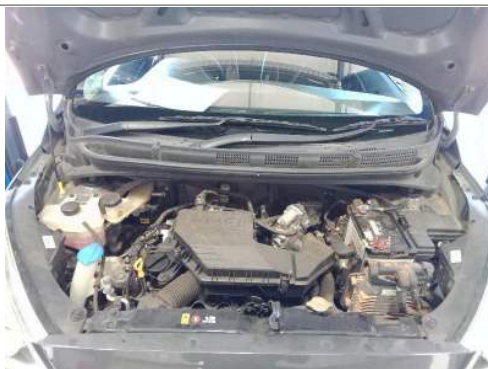
ENGINE 1

| Damage | Repair Way |
|---|---|
| Engine | Foreign substance on oil cap |
| Engine | Engine bay dirty. |

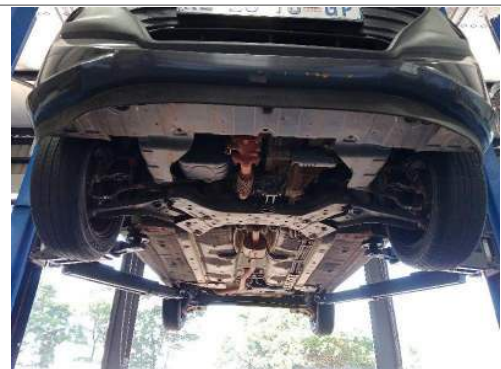
Front chassis

| Damage | Repair Way |
|---|---|
| Chassis Damaged | Repair |
