## CONDITION REPORT

Report No:  
2016906734  
DATE  
09/06/2025

| Manufacturer | HYUNDAI | Registration Number | JW70VHGP |
| Model | I10 1.1 MOTION 5-DR [2011-2018] | Register Number | |

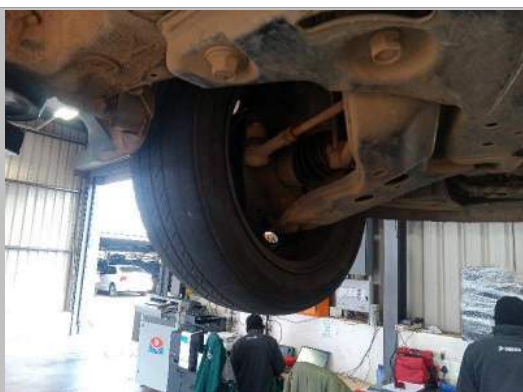
LF TYRE TREAD

| Damage | Repair Way |
|---|---|
| Tyre Front Left Smooth | Replace |

| | Size | Load/Speed Index | Manufacture | Model | Type* | Production Date | Tread Depth (mm) |
|---|---|---|---|---|---|---|---|
| Front Left | 165/60R14 | 75H | Velocity | Rota -eco | V | 5023 | 0 mm |

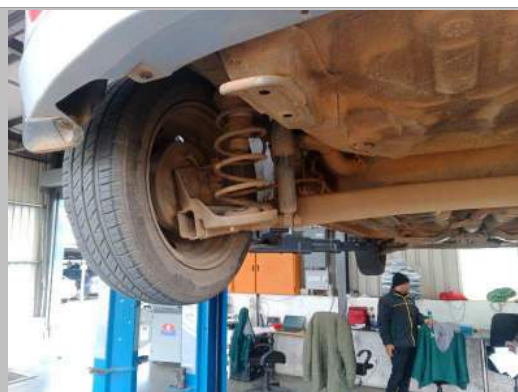
LR TYRE TREAD

| | Size | Load/Speed Index | Manufacture | Model | Type* | Production Date | Tread Depth (mm) |
|---|---|---|---|---|---|---|---|
| Rear Left | 165/60R14 | 75H | Velocity | Rota -eco | V | 5023 | 3 mm |

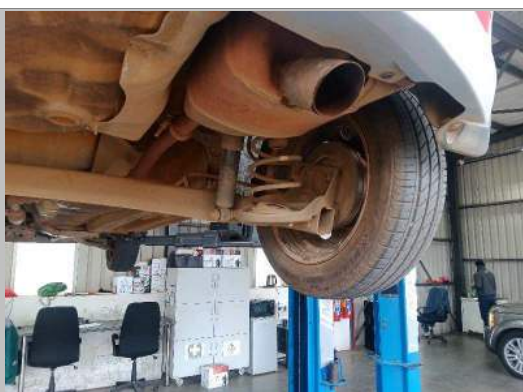
RR TYRE TREAD

| | Size | Load/Speed Index | Manufacture | Model | Type* | Production Date | Tread Depth (mm) |
|---|---|---|---|---|---|---|---|
| Rear Right | 165/60R14 | 75H | Velocity | Rota -eco | V | 5022 | 4 mm |

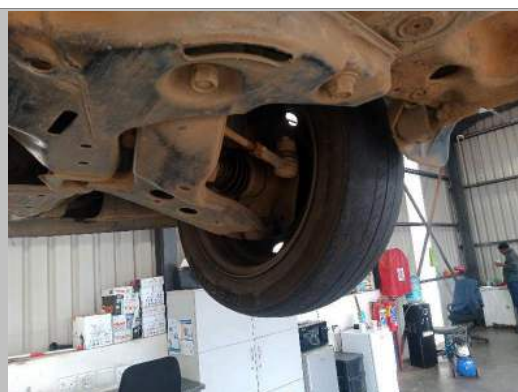
RF TYRE TREAD

| Damage | Repair Way |
|---|---|
| Tyre Front Right Damaged | Replace |

| | Size | Load/Speed Index | Manufacture | Model | Type* | Production Date | Tread Depth (mm) |
|---|---|---|---|---|---|---|---|
| Front Right | 165/60R14 | 75H | Velocity | Rota -eco | V | 5023 | 0 mm |

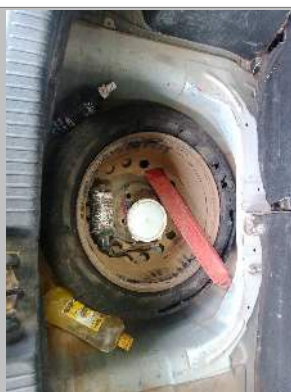
Spare wheel

| Damage | Repair Way |
|---|---|
| Spare Tyre Damaged | Replace |

| | Size | Load/Speed Index | Manufacture | Model | Type* | Production Date | Tread Depth (mm) |
|---|---|---|---|---|---|---|---|
| Spare | 165/60R14 | 75H | Dunlop | Sp sport | V | 0000 | 2 mm |

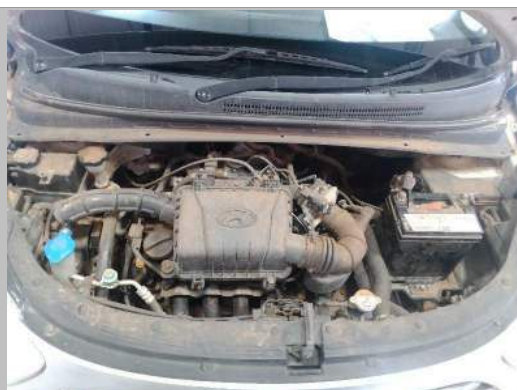
ENGINE 1

| Damage | Repair Way |
|---|---|
| Engine Oil Leak | Repair |
