MFC Auction House  
M57 Pretoria Rd, Glenmarais, KEMPTON PARK  
Gauteng

| Vehicle Type | PASSENGER VEHICLE | Registered Owner | MFC |

## CONDITION REPORT

Report No: 2016214157

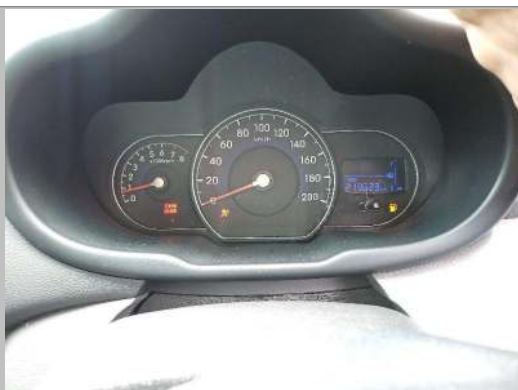
DASHBOARD (W/ ENGINE RUNNING)

General Comments: ACCORDING TO AGE AND MILEAGE OF VEHICLE NORMAL WEAR AND TEAR ON INTERIOR, EXTERIOR, ELECTRICAL AND MECHANICAL PARTS.ENGINE MANAGEMENT LIGHTS ILLUMINATED ON CLUSTER.

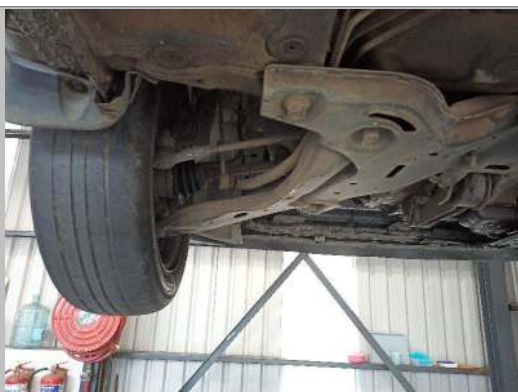
LF TYRE TREAD

| | Size | Load/Speed Index | Manufacture | Model | Type* | Production Date | Tread Depth (mm) |
|---|---|---|---|---|---|---|---|
| Front Left | 165/60R14 | 75H | Rapid | Radial | V | 3119 | 0 mm |

| Damage | Repair Way |
|---|---|
| Tyre Front Left Worn | Replace |

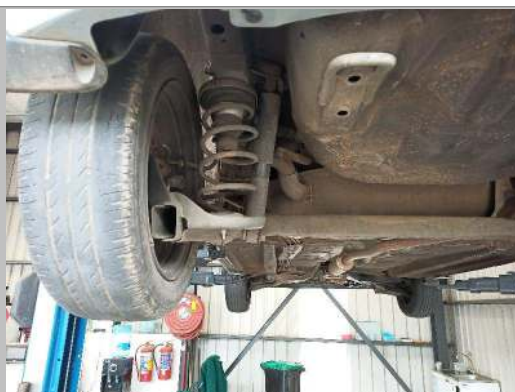
LR TYRE TREAD

| | Size | Load/Speed Index | Manufacture | Model | Type* | Production Date | Tread Depth (mm) |
|---|---|---|---|---|---|---|---|
| Rear Left | 165/60R14 | 75T | Goodride | Radial | V | 3913 | 0 mm |

| Damage | Repair Way |
|---|---|
| Tyre Rear Left Worn | Replace |

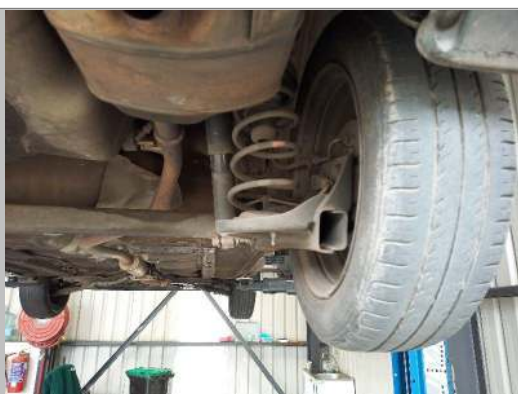
RR TYRE TREAD

| | Size | Load/Speed Index | Manufacture | Model | Type* | Production Date | Tread Depth (mm) |
|---|---|---|---|---|---|---|---|
| Rear Right | 165/60R14 | 75H | Goodride | Radial | V | 2217 | 1 mm |

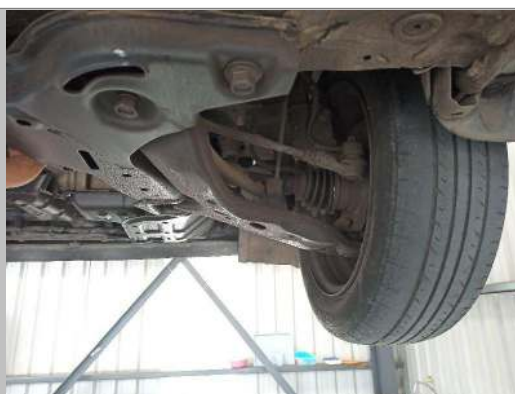
RF TYRE TREAD

| | Size | Load/Speed Index | Manufacture | Model | Type* | Production Date | Tread Depth (mm) |
|---|---|---|---|---|---|---|---|
| Front Right | 165/60R14 | 75H | Rapid | Radial | V | 3119 | 0 mm |

| Damage | Repair Way |
|---|---|
| Tyre Front Right Worn | Repair |

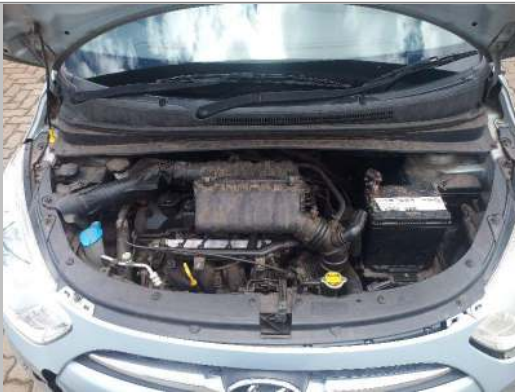
ENGINE 1

Engine Compartment: Foreign substance on oil filler cap.

| Damage | Repair Way |
|---|---|
| Engine Oil Leak | Repair |
