MFC Auction House
M57 Pretoria Rd, Glenmarais, KEMPTON PARK
Gauteng

DEKRA MFC
M57 Pretoria Rd - 1619
KEMPTON PARK - GT
08610 33572

VEHICLE INSPECTION

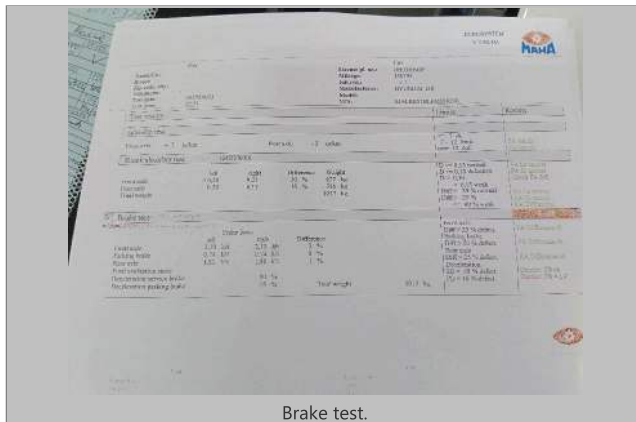
Brake test.

Left	Right		
	Braking Force [KN]	Braking Force [KN]	Axle Weight [KG]	Deceleration [m/s ²]
Front	2.19	2.13	-	
Rear	1.82	1.8	-	
Emergency / Parking	0.74	0.74	-

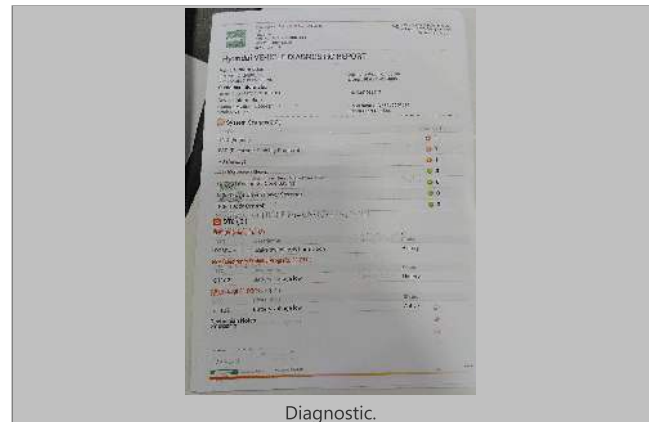
Diagnostic.

During the diagnostic no active error messages were detected. (See also attached Diagnostic Report. For more information regarding the Fault Codes (DTC) and the recommended rectifications please contact the workshops of the vehicle manufacture).

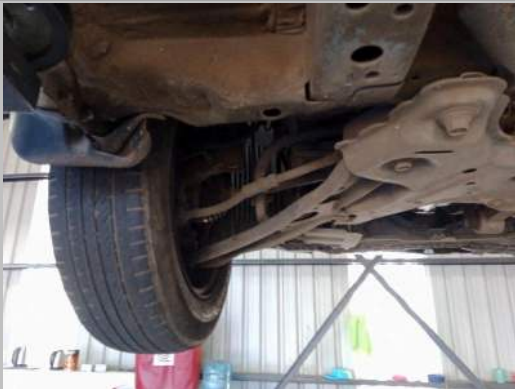
LF TYRE TREAD

Size	Load/Speed Index	Manufacture	Model	Type*	Production Date	Tread Depth (mm)
Front Left	175/70R14	84T	Durun	Radial	V	1918	0 mm
Front Right	175/70R14	84T	Durun	Radial	V	1918	0 mm
Rear Left	175/70R14	84H	Royal black	Radial	V	4517	2 mm
Rear Right	175/70R14	84T	Durun	Radial	V	1918	0 mm

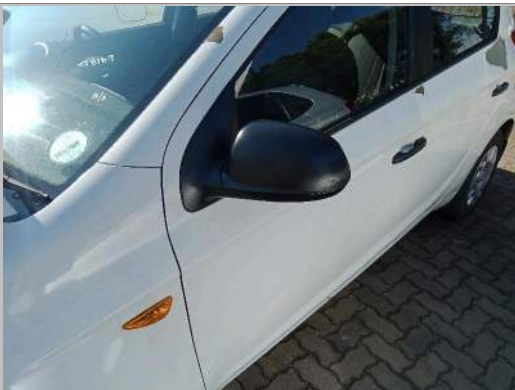
Door Front Left

Body • Exterior: Minor dents and scratches and stone chips to some body panels. Signs of repair work done to somebody panels. Poor alignment to somebody panels. Vehicle body in poor condition.
