CONDITION REPORT

Report No: 2016204818

MFC Auction House  
M57 Pretoria Rd, Glenmarais, KEMPTON PARK  
Gauteng

Vehicle Type	PASSENGER VEHICLE	Registered Owner	MFC
Manufacturer	HYUNDAI	Registration Number	KD67WKGP
Model	I20	Register Number	
VIN	MALBG512LNM069070	Date Of First Licensing	
Engine Number		Last COR	
Doors	5	License Expiry Date	29/02/2024
Color	BLUE	Power / Displacement	
Year Model		Paint Finish	M - METALLIC
Km Reading	75,827 KM	Fuel	PETROL
Cab / Body Type	HATCHBACK	Transmission	MANUAL

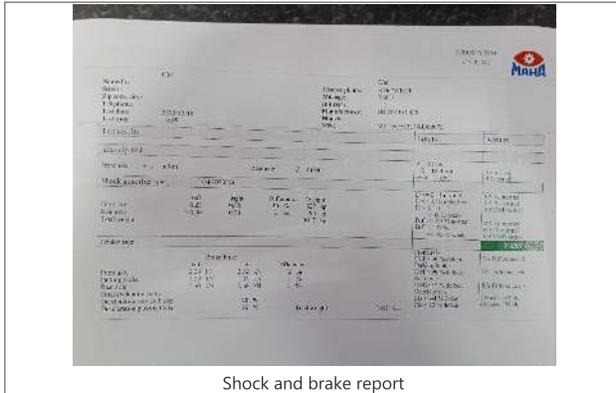
Shock and brake report

Left	Right	Axle Weight [KG]	Deceleration [m/s <sup>2</sup> ]
	Braking Force [KN]	Braking Force [KN]		
Front	2.2	2.3	-	
Rear	1.5	1.6	-	
Emergency / Parking	1.2	1.3	-

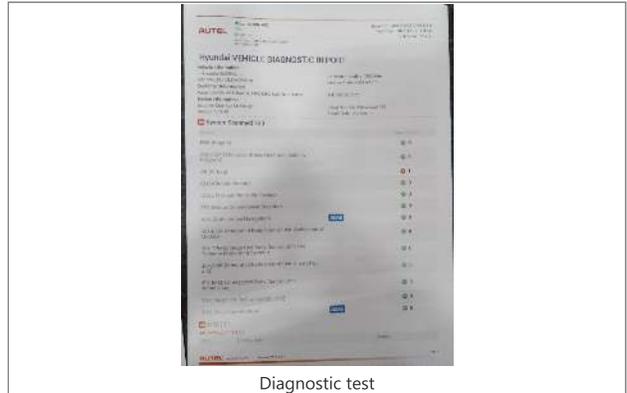
Diagnostic test

During the diagnostic no active error messages were detected. (See also attached Diagnostic Report. For more information regarding the Fault Codes (DTC) and the recommended rectifications please contact the workshops of the vehicle manufacture).

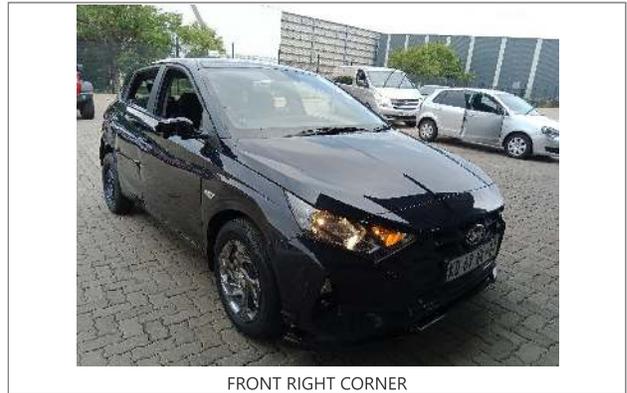
FRONT RIGHT CORNER

Damage	Repair Way
Indicator Light Front Right Broken	Replace
Fog Light Front Right Defective	Repair
Side Mirror Right Damaged	Replace
Front Bumper Damaged	Replace
Front Fender Right Dented	Repair
Rear Fender Right Damaged	Replace
Door Front Right Damaged	Replace
Door Rear Right Damaged	Replace
Rear bumper Damaged	Replace
Windscreen Cracked	Replace

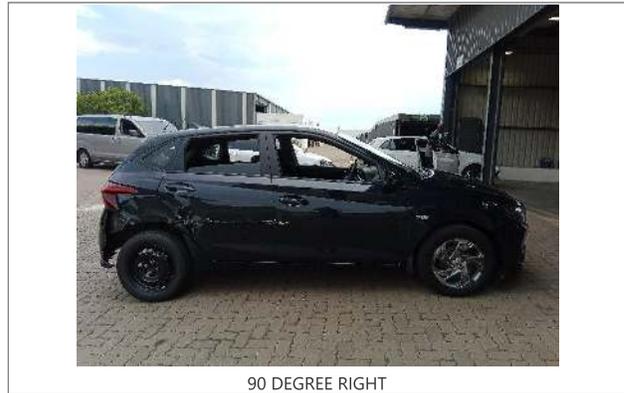
90 DEGREE RIGHT

Body • Exterior: Major dents scratches and stone chips on some body panels. Signs of spray work done on some body panels.

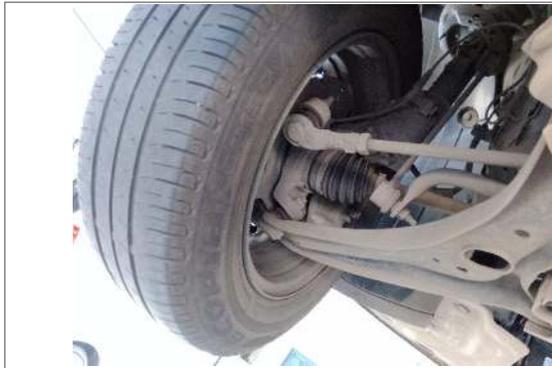
LF TYRE TREAD

Size	Load/Speed Index	Manufacture	Model	Type*	Production Date	Tread Depth (mm)
Front Left	185/65R15	88H	Bridgestone	Ecopia	V	1221	5 mm
Front Right	185/65R15	88H	Bridgestone	Ecopia	V	1221	5 mm
Rear Left	185/65R15	88H	Bridgestone	Ecopia	V	1221	5 mm
Rear Right	185/65R15	88H	Bridgestone	Ecopia	V	1221	7 mm
Spare	185/60R15	88H	Bridgestone	Ecopia	V	///////	5 mm
