MFC Auction House  
M57 Pretoria Rd, Glenmarais, KEMPTON PARK  
Gauteng

| Manufacturer | HYUNDAI | Registration Number | KMD460NW |

## CONDITION REPORT

Report No: 2016309753

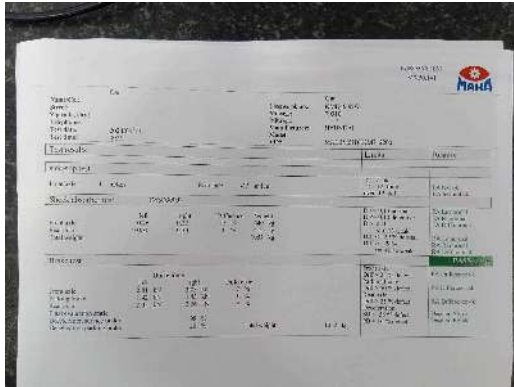
BRAKE AND SHOCK REPORT

## Brakes

### Brake Test Results

| | Left | Right | Axle Weight [KG] | Deceleration [m/s <sup>2</sup> ] |
| | Braking Force [KN] | Braking Force [KN] | | |
| Front | 2.8 | 3.0 | - | |
| Rear | 2.0 | 2.2 | - | |
| Emergency / Parking | 1.4 | 1.4 | - | |

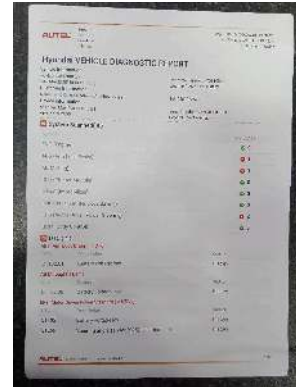
DIAGNOSTIC REPORT PAGE 1

During the diagnostic no active error messages were detected. (See also attached Diagnostic Report. For more information regarding the Fault Codes (DTC) and the recommended rectifications please contact the workshops of the vehicle manufacture).

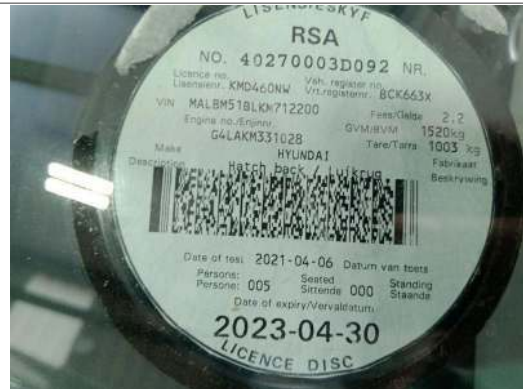
LICENSE DISC

| Doors | 5 | License Expiry Date | 30/04/2023 |

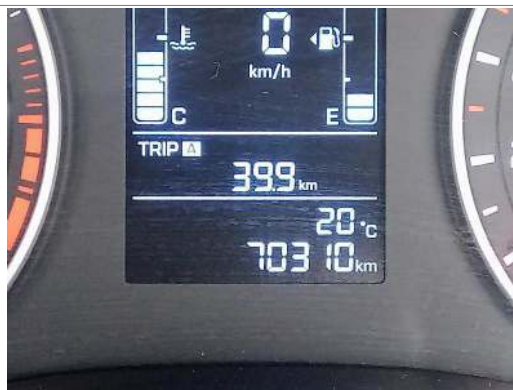
ODOMETER

| Km Reading | 70,310 KM | Fuel | PETROL |
