MFC Auction House  
M57 Pretoria Rd, Glenmarais, KEMPTON PARK  
Gauteng

## CONDITION REPORT

Report No: 2016325199

VIN: MALFC81ALMM169834

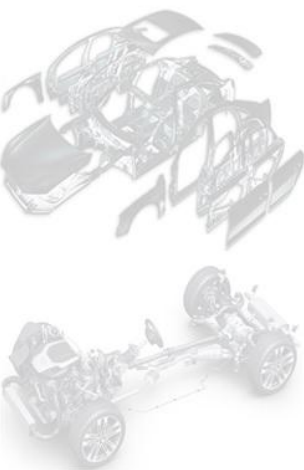
Front Bumper Paintwork • Scratched  
Front Fender Left Dented  
Rear Fender Left Paintwork • Scratched  
Door Front Left Paintwork • Scratched  
Door Rear Left Paintwork • Scratched  
Rear bumper Paintwork • Scratched

Repair  
Repair  
Repair  
Repair  
Repair  
Repair

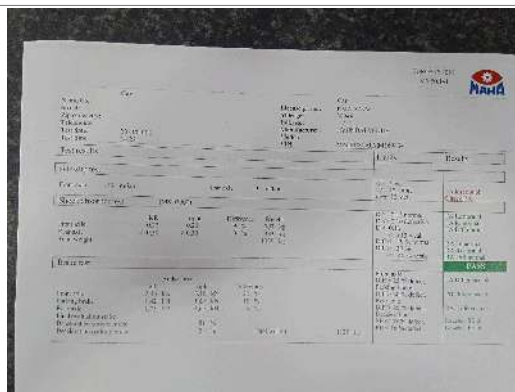
SHOCK & BRAKE REPORT

| | Left | Right | Axle Weight [KG] | Deceleration [m/s <sup>2</sup> ] |
| | Braking Force [KN] | Braking Force [KN] | | |
| Front | 2.4 | 3.1 | - | |
| Rear | 1.7 | 1.6 | - | |
| Emergency / Parking | 1.4 | 1.6 | - | |

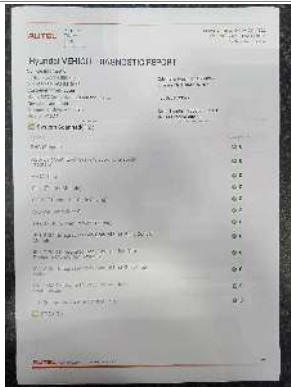
DIAGNOSTIC REPORT PAGE 1

During the diagnostic no active error messages were detected. (See also attached Diagnostic Report. For more information regarding the Fault Codes (DTC) and the recommended rectifications please contact the workshops of the vehicle manufacture).
