## CONDITION REPORT

Report No:  
2016994558  
DATE  
28/08/2025

| Manufacturer | HYUNDAI | Registration Number | NONE |
| Model | CRETA 1.5 PREMIUM [2020-2022] | Register Number | |

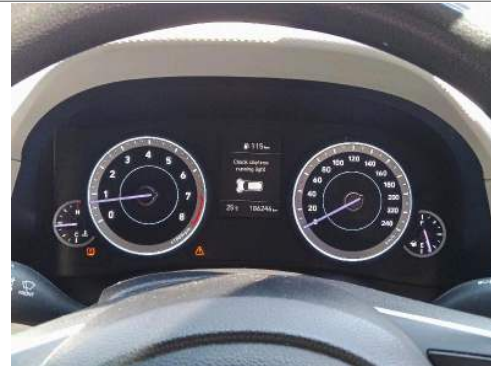
DASHBOARD (W/ ENGINE RUNNING)

| | Damage | Repair Way |
|--|---|---|
| | Warning lights illuminated on dashboard | Repair |

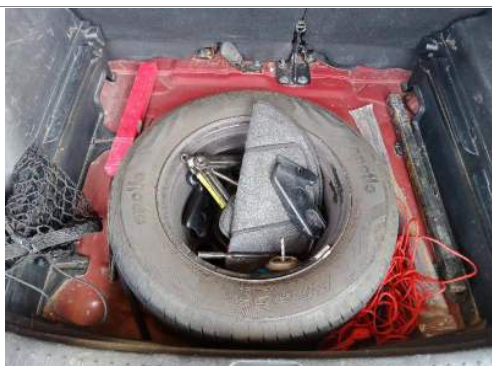
Spare wheel and Accessories

| | Damage | Repair Way |
|--|---|---|
| | Inner Boot Floor Pan and Spare Wheel Well Welded | Repair |

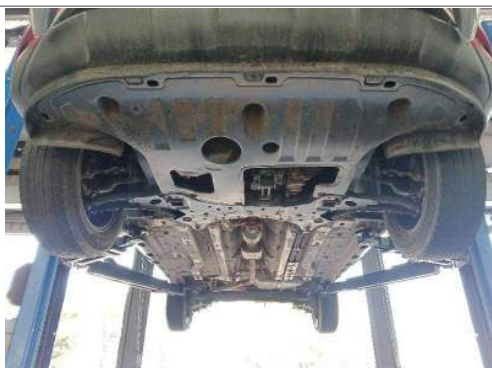
Front chassis

| | Damage | Repair Way |
|--|---|---|
| | Chassis Damaged | Repair |
