MFC Auction House  
M57 Pretoria Rd, Glenmarais, KEMPTON PARK  
Gauteng

Vehicle Type	PASSENGER VEHICLE	Registered Owner	
Manufacturer	TOYOTA	Registration Number	KF28RDGP
Model	ETIOS SD 1.5 XS [2015-2016]	Register Number	
VIN	MBJB29BT300101377	Date Of First Licensing	
Engine Number		Last COR	
Doors	4	License Expiry Date	
Color	WHITE	Power / Displacement	
Year Model	2015	Paint Finish	TWO COAT UNI
Km Reading	282,091 KM	Fuel	PETROL
Cab / Body Type	SEDAN	Transmission	MANUAL

VEHICLE INSPECTION

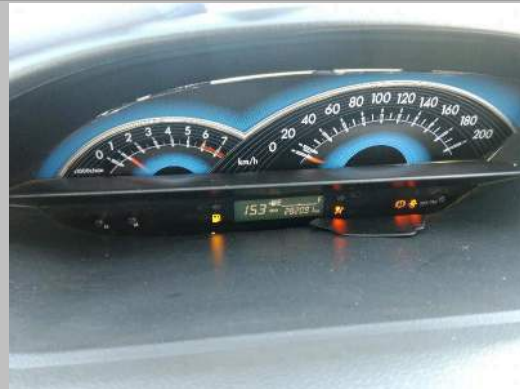
DASHBOARD (W/ ENGINE RUNNING)

Damage	Repair Way
Engine Oil Leak	Repair
Engine Management Lights Set	Repair
Headlight Left Damaged	Replace
Headlight Right Damaged	Replace
Dash Padding Damaged	Replace
Front Bumper Damaged	Repair
Bonnet Damaged	Repair
Front Fender Left Damaged	Repair
Front Fender Right Damaged	Repair
Rear Fender Left Damaged	Repair
Rear Fender Right Damaged	Repair
Door Front Left Damaged	Repair
Door Front Right Damaged	Repair
Door Rear Left Damaged	Repair
Door Rear Right Damaged	Repair
Boot Lid / Hatch door Damaged	Repair
Rear bumper Damaged	Repair
Roof Damaged	Repair
Main Beam Left Damaged	Repair
Main Beam Right Welded	Repair
Gearbox Oil Leak	Repair
CV Joint(s) Boot(s) Front Right (inner/outer) Damaged	Replace

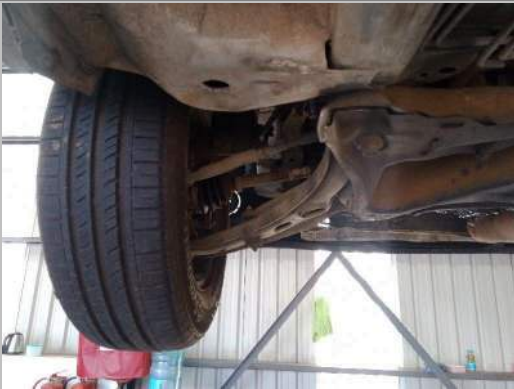
LF TYRE TREAD

Size	Load/Speed Index	Manufacture	Model	Type*	Production Date	Tread Depth (mm)
Front Left	185/65R14	86T	Symmetry	Radial	V	4123	3 mm
Front Right	185/65R14	86T	Symmetry	Radial	V	4123	3 mm
Rear Left	185/65R14	86T	Symmetry	Radial	V	4123	3 mm
Rear Right	185/65R14	86T	Symmetry	Radial	V	2623	3 mm
