## CONDITION REPORT

Report No:  
2016946719  
DATE  
15/07/2025

| Manufacturer | NISSAN | Registration Number | NO REG |
| Model | ALMERA 1.5 ACENTA AT [2016-2024] | Register Number | |

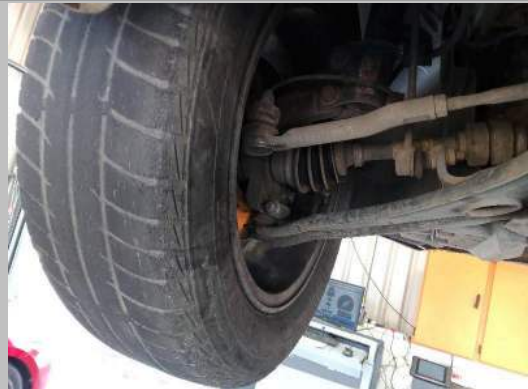
LF TYRE TREAD

| Damage | Repair Way |
|---|---|
| Tyre Front Left Smooth | Replace |

| | Size | Load/Speed Index | Manufacture | Model | Type* | Production Date | Tread Depth (mm) |
|---|---|---|---|---|---|---|---|
| Front Left | 185/65R15 | 92T | Barum | Brillantis | V | 3624 | 0 mm |

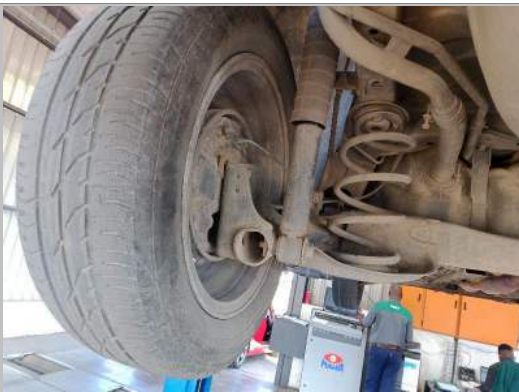
LR TYRE TREAD

| Damage | Repair Way |
|---|---|
| Tyre Rear Left Excessive Wear & Tear | Replace |

| | Size | Load/Speed Index | Manufacture | Model | Type* | Production Date | Tread Depth (mm) |
|---|---|---|---|---|---|---|---|
| Rear Left | 185/60R15 | 84H | Continental | Contact | V | 3118 | 1 mm |

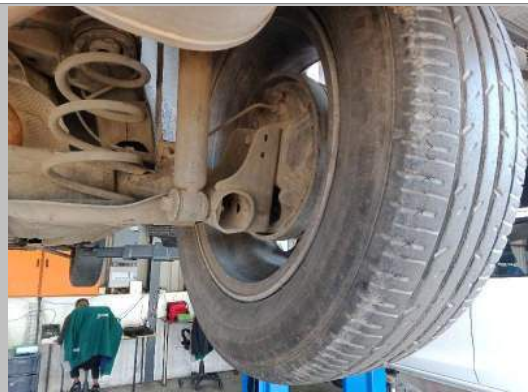
RR TYRE TREAD

| Damage | Repair Way |
|---|---|
| Tyre Rear Right Excessive Wear & Tear | Replace |

| | Size | Load/Speed Index | Manufacture | Model | Type* | Production Date | Tread Depth (mm) |
|---|---|---|---|---|---|---|---|
| Rear Right | 195/65R15 | 91V | Dunlop | Sport | V | 4417 | 0 mm |

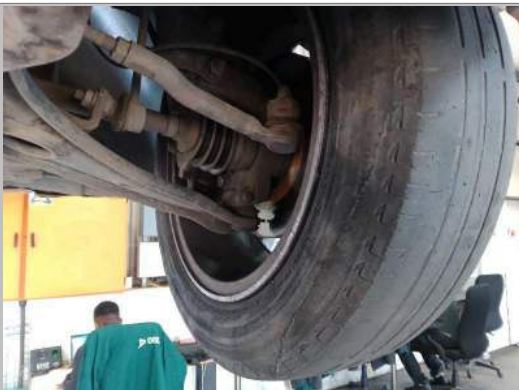
RF TYRE TREAD

| Damage | Repair Way |
|---|---|
| Tyre Front Right Smooth | Replace |

| | Size | Load/Speed Index | Manufacture | Model | Type* | Production Date | Tread Depth (mm) |
|---|---|---|---|---|---|---|---|
| Front Right | 175/65R15 | 84H | Bridgestone | Ecopia | V | 0000 | 0 mm |

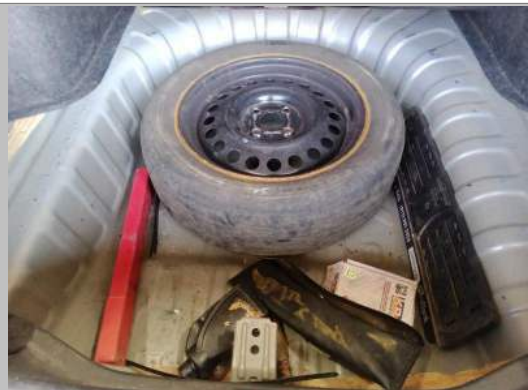
Sparewheel

| Damage | Repair Way |
|---|---|
| Spare Tyre Smooth | Replace |

| | Size | Load/Speed Index | Manufacture | Model | Type* | Production Date | Tread Depth (mm) |
|---|---|---|---|---|---|---|---|
| Spare | 185/60R15 | 84H | Bridgestone | Turanza | V | 0000 | 0 mm |

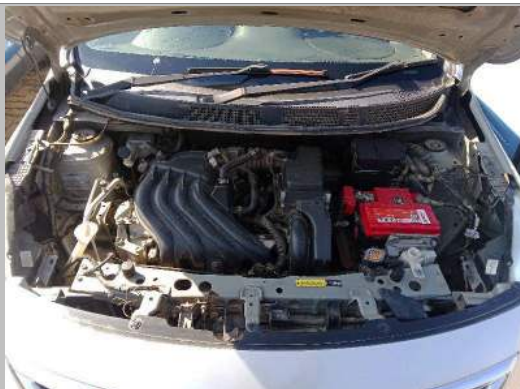
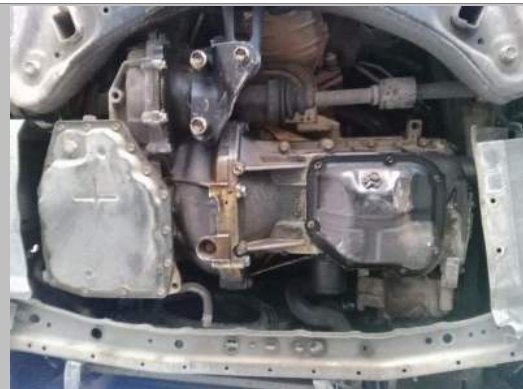
| Damage | Repair Way |
|---|---|
| Engine Oil Leak | Repair |

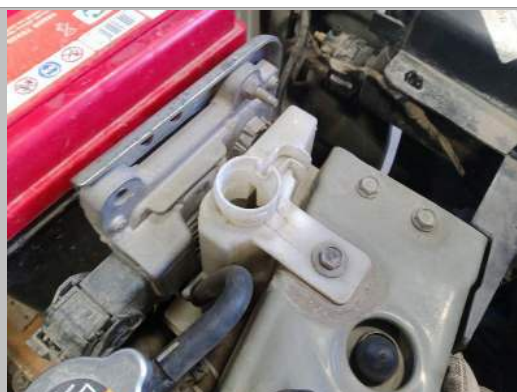
Coolant reservoir

| Damage | Repair Way |
|---|---|
| Expansion Bottle Damaged | Repair |
