## CONDITION REPORT

Report No: 2016276051

DATE  
21/02/2024

| Manufacturer | NISSAN | Registration Number | JS73PCGP |

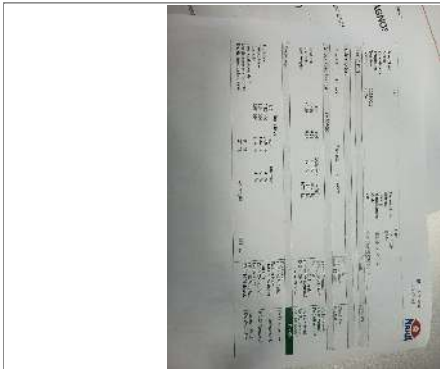
| | Left | Right | | |
|---|---|---|---|---|
| Front | 2.58 | 2.69 | - | |
| Rear | 2.08 | 2.16 | - | |
| Emergency / Parking | 1.34 | 1.46 | - | |

Brake test

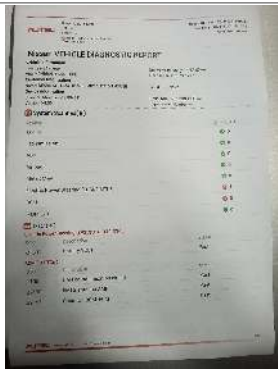
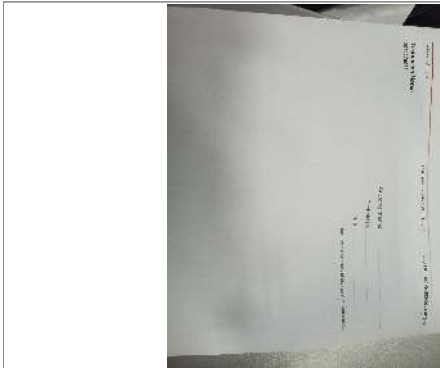
During the diagnostic no active error messages were detected. (See also attached Diagnostic Report. For more information regarding the Fault Codes (DTC) and the recommended rectifications please contact the workshops of the vehicle manufacture).

diagnostics

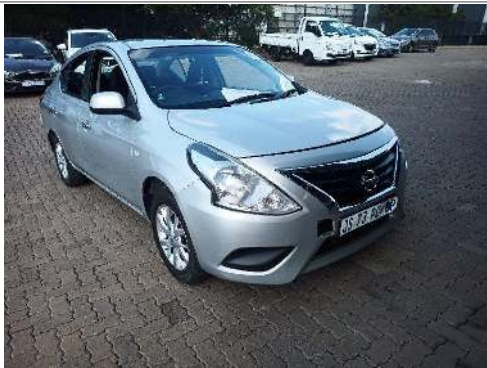
FRONT RIGHT CORNER

| Damage | Repair Way |
|---|---|
| Body and exterior | Signs of impact damage to front of vehicle. |

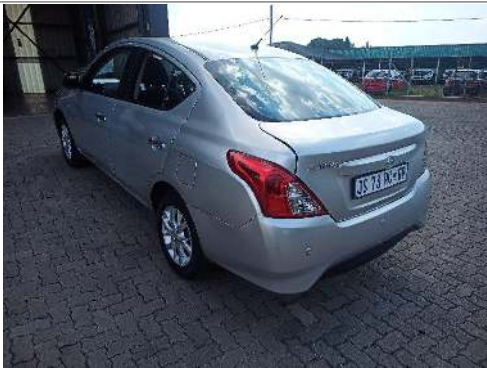
REAR LEFT CORNER

| Damage | Repair Way |
|---|---|
| Body and exterior | Signs of impact damage to rear of vehicle. |

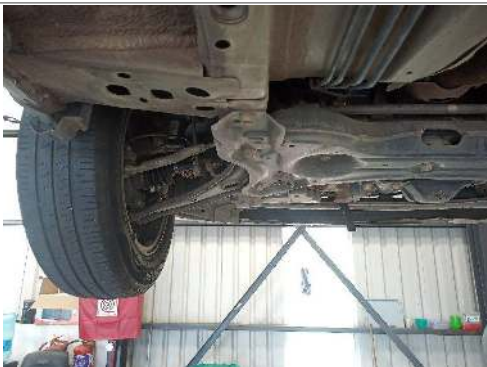
LF TYRE TREAD

| | Size | Load/Speed Index | Manufacture | Model | Type* | Production Date | Tread Depth (mm) |
|---|---|---|---|---|---|---|---|
| Front Left | 185/65R15 | 88H | Lanvigator | Radial | V | 2023 | 3 mm |
