## CONDITION REPORT

Report No: 2016400506

MFC Auction House  
M57 Pretoria Rd, Glenmarais, KEMPTON PARK  
Gauteng

| Manufacturer | DATSUN | Registration Number | CX62870 |

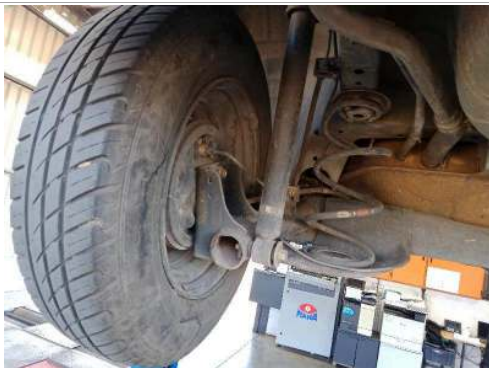
LR TYRE TREAD

| | Size | Load/Speed Index | Manufacture | Model | Type* | Production Date | Tread Depth (mm) |
|---|---|---|---|---|---|---|---|
| Rear Left | 155/80R13 | 79T | Velocity | Reacta | V | 4720 | 5 mm |

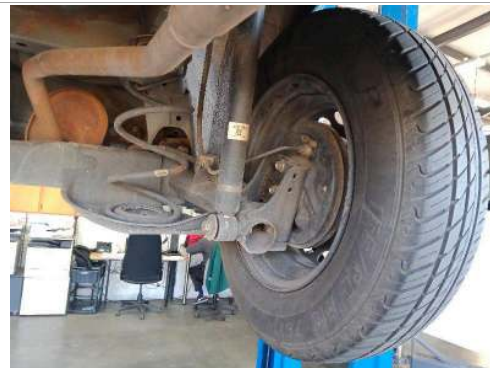
RR TYRE TREAD

| | Size | Load/Speed Index | Manufacture | Model | Type* | Production Date | Tread Depth (mm) |
|---|---|---|---|---|---|---|---|
| Rear Right | 155/80R13 | 79T | Velocity | Reacta | V | 4720 | 5 mm |

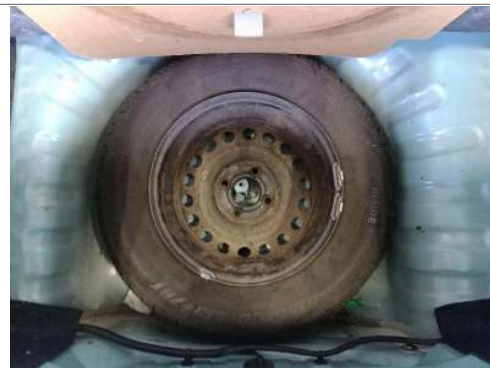
Sparewheel

| | Size | Load/Speed Index | Manufacture | Model | Type* | Production Date | Tread Depth (mm) |
|---|---|---|---|---|---|---|---|
| Spare | 155/80R13 | 79T | Velocity | Reacta | V | ////// | 5 mm |
