## CONDITION REPORT

Report No:  
2016903310  
DATE  
05/06/2025

Vehicle Type	PASSENGER VEHICLE	Registered Owner	
Manufacturer	DATSON	Registration Number	KHN006MP
Model	GO 1.2 LUX ULC 5-DR [2019-2021]	Register Number	
VIN	MDHZBAA0Z0519290	Date Of First Licensing	
Engine Number		Last COR	
Doors	5	License Expiry Date	30/04/2026
Color	BLUE	Power / Displacement	
Year Model	2021	Paint Finish	TWO COAT UNI
Km Reading	56,122 KM	Fuel	PETROL
Cab / Body Type	HATCHBACK	Transmission	MANUAL

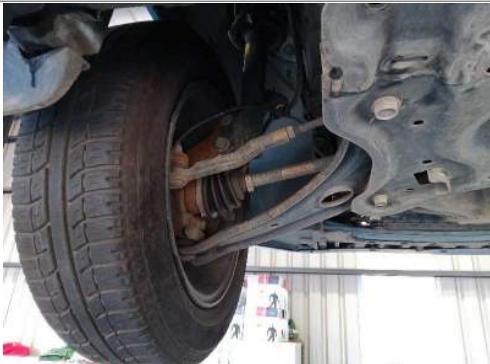
LF TYRE TREAD

Size	Load/Speed Index	Manufacture	Model	Type*	Production Date	Tread Depth (mm)
Front Left	175/65 R14	82T	Sava	Effecta	V	0623	4 mm
Front Right	165/70 R14	81T	Apollo	Amazer	V	1121	5 mm
Rear Left	175/65 R14	82T	Sava	Effecta	V	0623	6 mm
Rear Right	175/65 R14	82T	Sava	Effecta	V	0623	5 mm
Spare	185/60 R14	82H	Dunlop	Sp-Sport	V	2121	0 mm

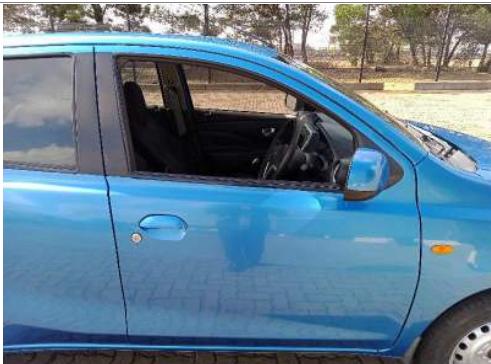
Damage	Repair Way
Seat Front Right Damaged	Repair
Parcel Tray Damaged	Repair
Steering Wheel Trim Defective	Repair
Front Bumper Paintwork • Scratched	Repair
Front Fender Right Damaged	Repair
Rear Fender Left Paintwork • Scratched	Repair
Rear Fender Right Paintwork • Scratched	Repair
Door Front Left Paintwork • Scratched	Repair
Door Front Right Dented	Repair
Door Rear Left Paintwork • Scratched	Repair
Boot Lid / Hatch door Paintwork • Scratched	Repair
Rear bumper Paintwork • Scratched	Repair
Tyre Front Left Damaged	Replace
Spare Tyre Damaged	Replace
Chassis Dented	Repair
Brakes	Front L/R brake pipes strapped with cable ties
Body and Exterior	Dents and scratches on some body panels
Tyres and rims	Front left and right tyre sizes different
Engine	Engine bay dirty.
