## CONDITION REPORT

Report No:  
2016998625  
DATE  
01/09/2025

| Manufacturer | RENAULT | Registration Number | KC03KRGP |
| Model | KWID | Register Number | |

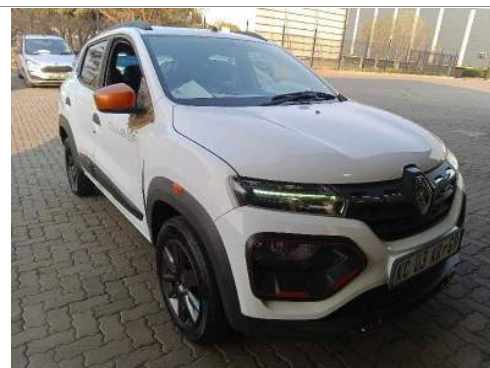
FRONT RIGHT CORNER

| Side Mirror Right Damaged | Replace |
| Front Fender Right Dented | Repair |
| Door Front Right Damaged | Repair |
| Sill Panel Right Damaged | Repair |

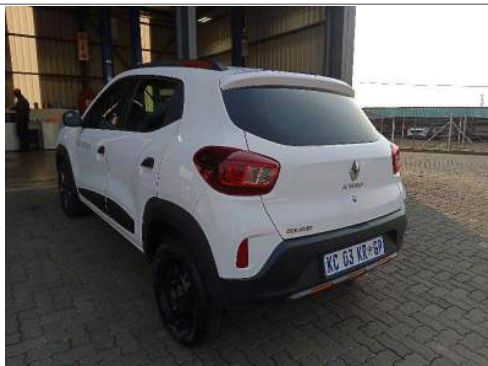
REAR LEFT CORNER

| Rear bumper Paintwork • Scratched | Repair |

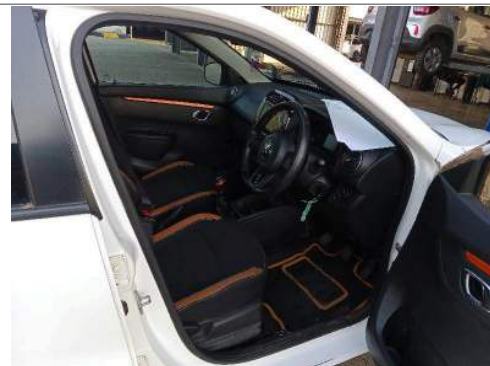
INTERIOR (FRONT DRIVER DOOR)

Interior: Vehicle interior dirty and some panels scratched

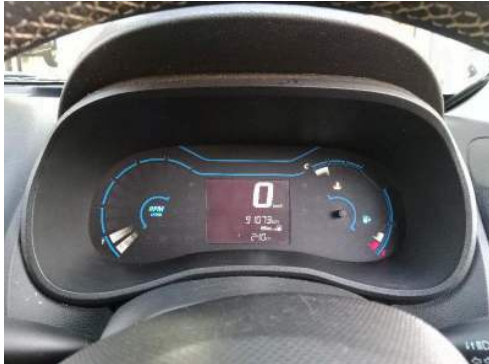
DASHBOARD (W/ ENGINE RUNNING)

| No | System | Code | Description | Status |
|---|---|---|---|---|
| 1 | INJ(INJECTION) | DTC033531 | ENGINE SPEED SENSOR SIGNAL NO SIGNAL | |

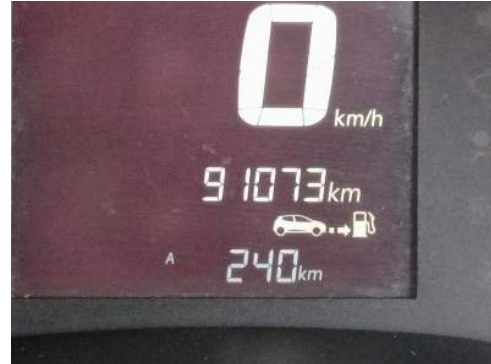
ODOMETER

| Km Reading | 91,073 KM | Fuel | PETROL |

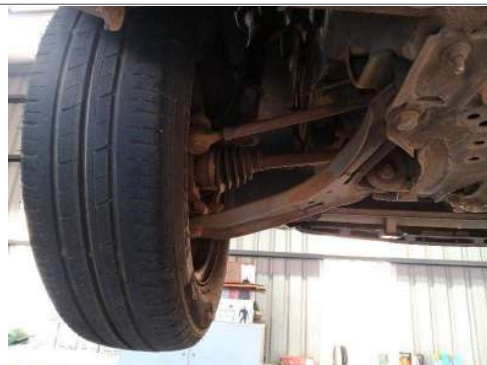
LF TYRE TREAD

| | Size | Load/Speed Index | Manufacture | Model | Type* | Production Date | Tread Depth (mm) |
|---|---|---|---|---|---|---|---|
| Front Left | 175/65 R14 | 82H | Windforce | Catchfors | V | 0824 | 2 mm |

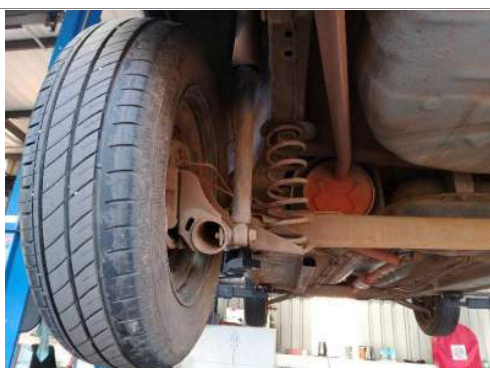
LR TYRE TREAD

| | Size | Load/Speed Index | Manufacture | Model | Type* | Production Date | Tread Depth (mm) |
|---|---|---|---|---|---|---|---|
| Rear Left | 165/70 R14 | 81T | Apollo | Amazer | V | 0821 | 2 mm |

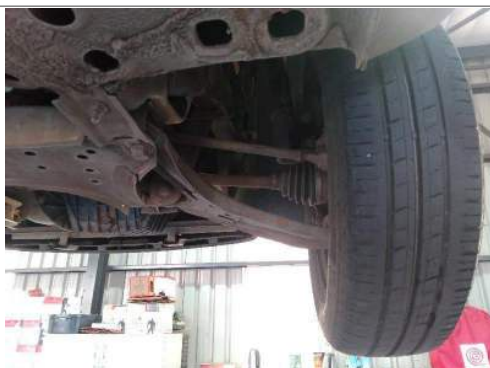
RF TYRE TREAD

| | Size | Load/Speed Index | Manufacture | Model | Type* | Production Date | Tread Depth (mm) |
|---|---|---|---|---|---|---|---|
| Front Right | 175/65 R14 | 82H | Windforce | Catchfors | V | 0724 | 1 mm |

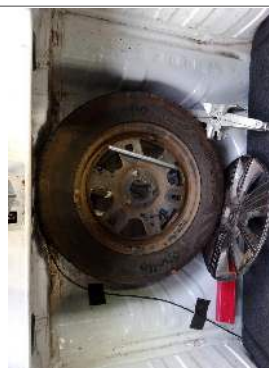
Spare wheel and Accessories

| Spare Tyre Damaged | Replace |

| | Size | Load/Speed Index | Manufacture | Model | Type* | Production Date | Tread Depth (mm) |
|---|---|---|---|---|---|---|---|
| Spare | 165/70 R14 | 81T | Apollo | Amazer | V | 0621 | 0 mm |

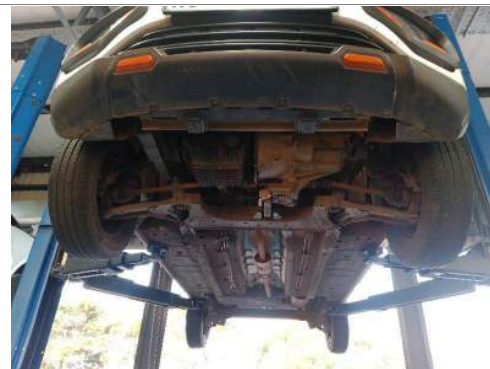
Front chassis

| Chassis Damaged | Repair |
