MFC Auction House  
M57 Pretoria Rd, Glenmarais, KEMPTON PARK  
Gauteng

| Manufacturer | RENAULT | Registration Number | JK22WGGP |

## CONDITION REPORT

Report No: 2016762833

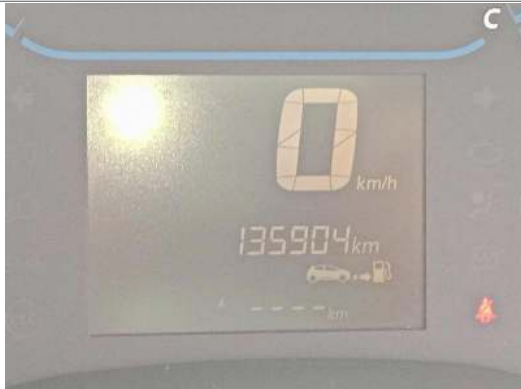
ODOMETER

| Km Reading | 135,903 KM | Fuel | PETROL |

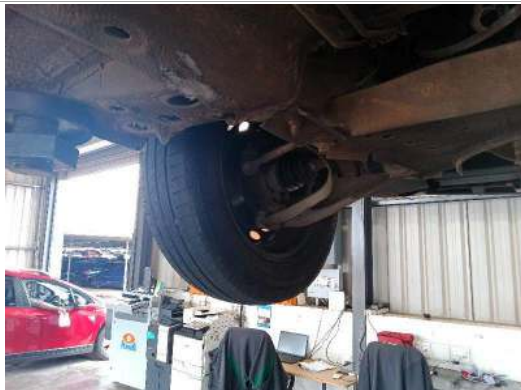
LF TYRE TREAD

| | Size | Load/Speed Index | Manufacture | Model | Type* | Production Date | Tread Depth (mm) |
|---|---|---|---|---|---|---|---|
| Front Left | 175/65R14 | 82T | Road stone | Eurovis | V | 5121 | 3 mm |

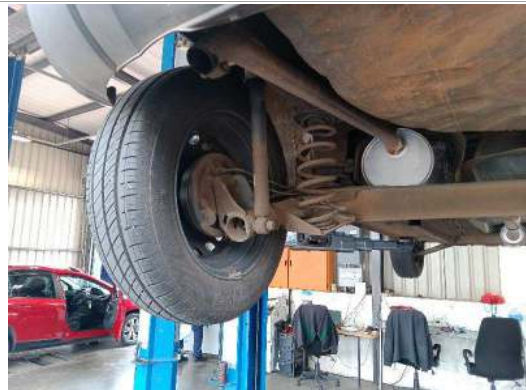
LR TYRE TREAD

| | Size | Load/Speed Index | Manufacture | Model | Type* | Production Date | Tread Depth (mm) |
|---|---|---|---|---|---|---|---|
| Rear Left | 165/70R14 | 81T | Apollo | Amazer | V | 4619 | 4 mm |

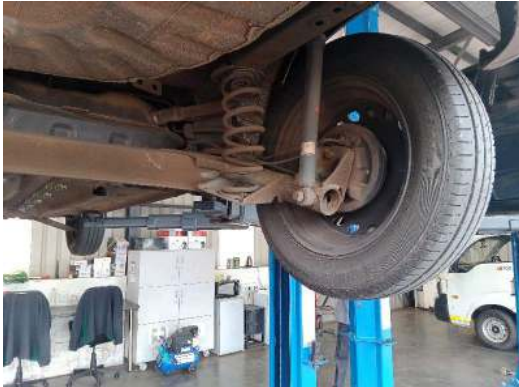
RR TYRE TREAD

| | Size | Load/Speed Index | Manufacture | Model | Type* | Production Date | Tread Depth (mm) |
|---|---|---|---|---|---|---|---|
| Rear Right | 175/65R14 | 82T | Road stone | Eurovis | V | 5121 | 4 mm |

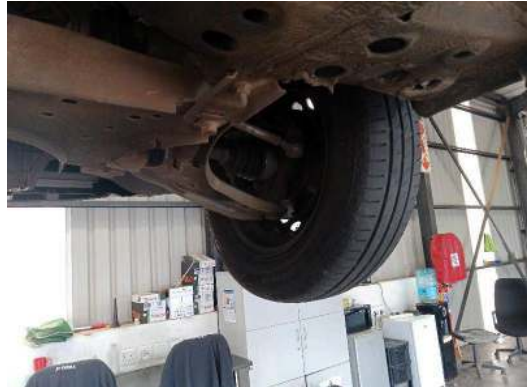
RF TYRE TREAD

| | Size | Load/Speed Index | Manufacture | Model | Type* | Production Date | Tread Depth (mm) |
|---|---|---|---|---|---|---|---|
| Front Right | 175/65R14 | 82T | Road stone | Eurovis | V | 5121 | 3 mm |
