MFC Auction House
M57 Pretoria Rd, Glenmarais, KEMPTON PARK
Gauteng

DEKRA MFC
M57 Pretoria Rd - 1619
KEMPTON PARK - GT
08610 33572

VEHICLE INSPECTION

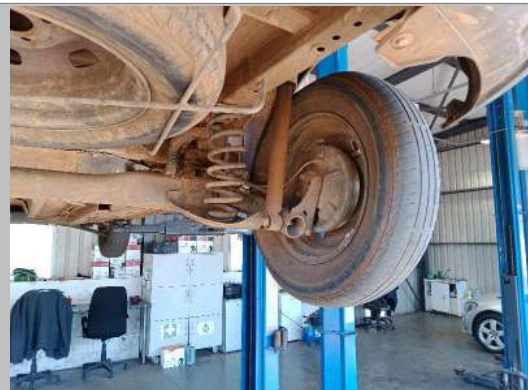
RR TYRE TREAD

Damage	Repair Way
Switch Electrical Window Winder front right Malfunction	Repair
Dim Light Left Malfunction	Repair
Dim Light Right Malfunction	Repair
Bonnet Dented	Repair
Front Fender Left Dented	Repair
Front Fender Right Dented	Repair
Rear Fender Left Paintwork • Scratched	Repair
Door Front Left Damaged	Replace
Door Front Right Paintwork • Scratched	Repair
Door Rear Left Paintwork • Scratched	Repair
Door Rear Right Paintwork • Scratched	Repair
Rear bumper Paintwork • Scratched	Repair
Roof Corrosion	Repair
Windscreen Chipped	Repair
Window Front Door Left Damaged	Replace
Brake disc 1. Axle right Corrosion	Replace
Tyre Rear Right Defective	Repair
Oil slugged on oil cap	Repair
L/F fender liner damage	Replace

Size	Load/Speed Index	Manufacture	Model	Type*	Production Date	Tread Depth (mm)
Front Left	185/60R14	82H	Dayton	Journey	V	3918	1 mm
Front Right	165/70R14	81T	Apollo	Amazer	V	3621	1 mm
Rear Left	165/70R14	81T	Goodyear	Duragrip	V	3509	2 mm
Rear Right	165/80R14	85T	Ceat	Fuel smart	V	3022	2 mm
Spare	165/80R14	85T	Ceat	Fuel smart	V	////	2 mm
