CONDITION REPORT

Report No: 2016312367

DATE  
20/03/2024

Vehicle Type	PASSENGER VEHICLE	Registered Owner	MFC AUCTION HOUSE
Manufacturer	TOYOTA	Registration Number	KP64VBGP
Model	AVANZA	Register Number	
VIN	MHKM5FB2N0K002339	Date Of First Licensing	
Engine Number		Last COR	
Doors	5	License Expiry Date	20/03/2024
Color	GOLDEN	Power / Displacement	
Year Model		Paint Finish	M - METALLIC
Km Reading	134,969 KM	Fuel	PETROL
Cab / Body Type	HATCHBACK	Transmission	MANUAL

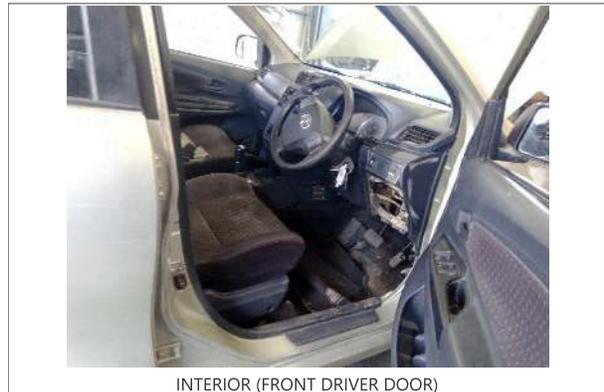
Damage	Repair Way
Service Brake Performance Rear Axle Left / Right Difference out of legal range	Repair
Parking Brake Performance Left / Right Difference out of legal range	Repair
Shock Absorber Rear Left Leak	Replace
Shock Absorber Rear Right Leak	Replace
Control Arm Bush(es) Front Axle Left Cracked	Replace
Control Arm Bush(es) Front Axle Right Cracked	Replace
Rim Front Right Damaged	Repair
Radiator Cradle Damaged	Replace
Body exterior.	Residual traces of poor repair work done on all b
Body exterior.	Minor dents scratches and stone chips on some bod.
Body exterior.	Signs of spray work done on all body panels.
Bottom of engine is fully covered	Body exterior
Comments	Vehicle is possible a code 3
Warning light illuminated	Repair
Driver window not closing properly	Repair

INTERIOR (FRONT DRIVER DOOR)

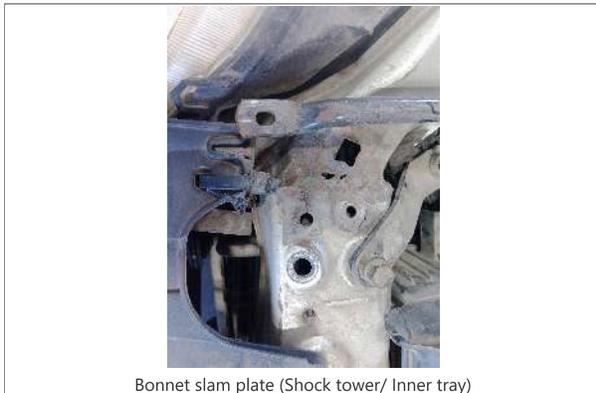
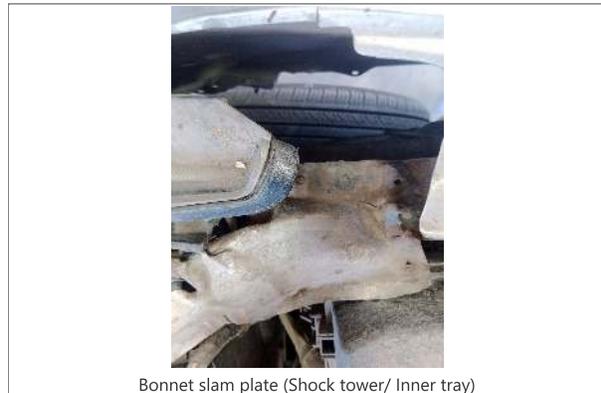
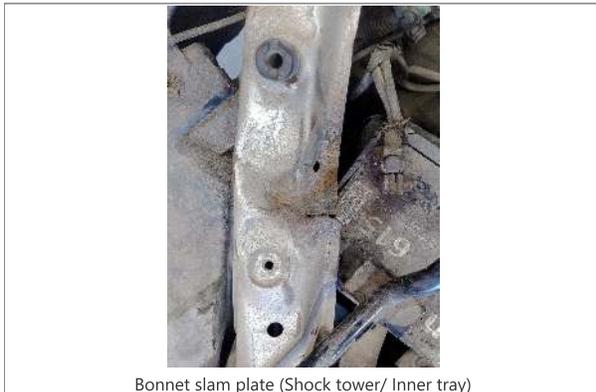
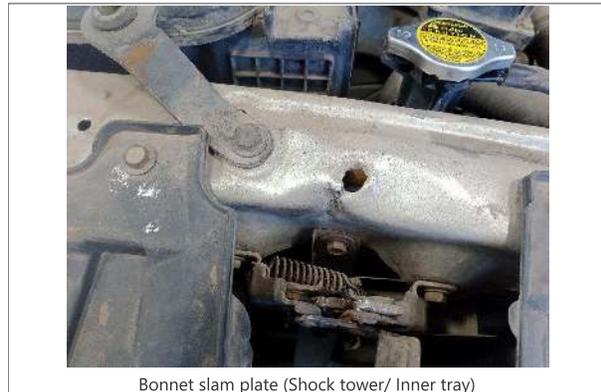
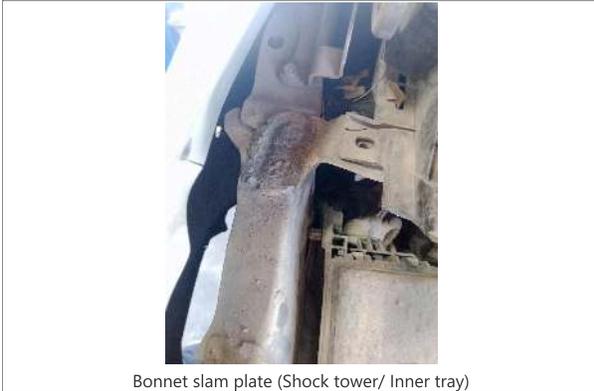
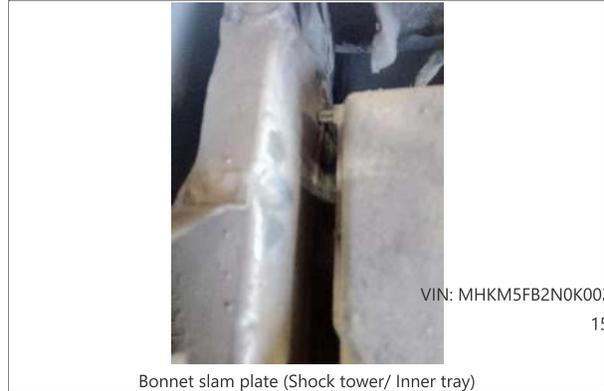
General Comments: ACCORDING TO THE AGE AND MILEAGE OF THE VEHICLE, NORMAL WEAR AND TEAR MARKS ARE VISIBLE ON THE INTERIOR, EXTERIOR, ELECTRICAL AND MECHANICAL PARTS. VEHICLE IS CUT & JOIN.

Bonnet slam plate (Shock tower/ Inner tray)

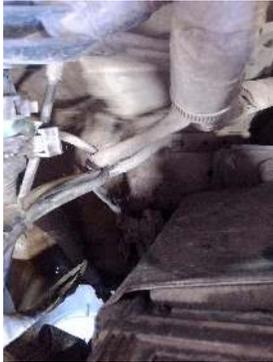
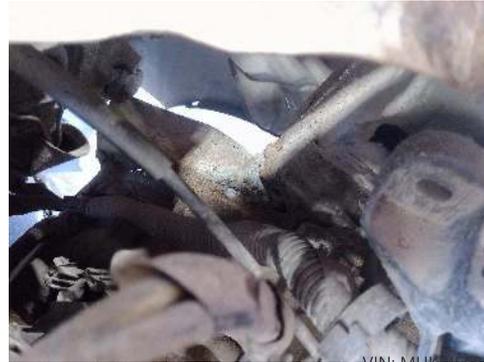
Bonnet slam plate (Shock tower/ Inner tray)

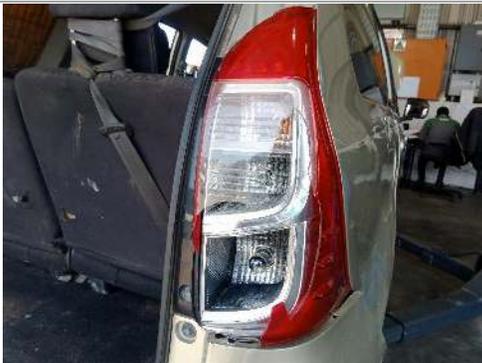
Damage	Repair Way
Battery clamps Defective	Replace
Indicator Light Front Left Damaged	Replace
Indicator Light Front Right Damaged	Replace
Tail Light Left Damaged	Replace
Tail Light Right Damaged	Replace
Headlight Left Damaged	Replace
Seat Front Right Torn / Cut	Repair
Seat Rear Torn / Cut	Repair
Sun Visor Left Missing	Replace
Door Panel Front Right Damaged	Repair
Carpet Rear Torn / Cut	Repair
Side Mirror Right Damaged	Replace
Front Bumper Damaged	Repair
Bonnet Damaged	Repair
Bonnet slam plate (Shock tower/ Inner tray) Welded	Repair
A • Pillar Right Dented	Repair
C • Pillar Right Residual Traces of Repair	Repair
Front Fender Left Dented	Repair
Front Fender Right Damaged	Repair
Rear Fender Left Damaged	Repair
Rear Fender Right Damaged	Repair
Front Fender Right / Inner Tray Welded	Replace
Door Front Right Damaged	Replace
Door Rear Left Paintwork • Scratched	Repair
Door Rear Right Residual Traces of Repair	Replace
Rear bumper Damaged	Repair

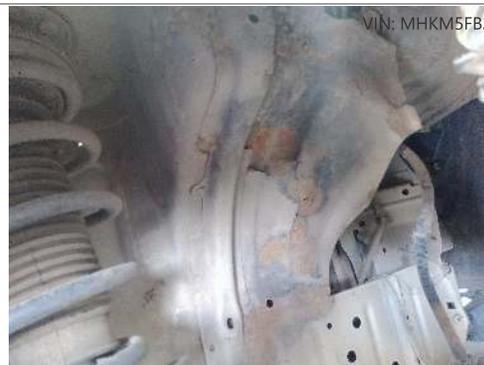
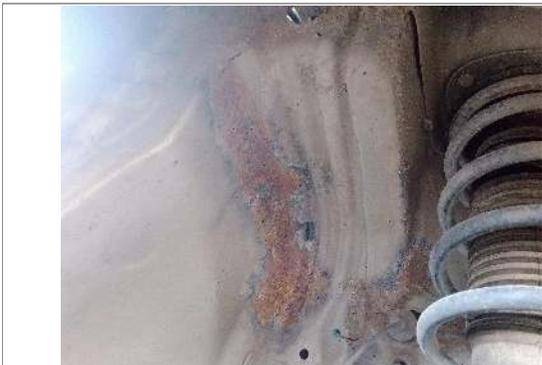
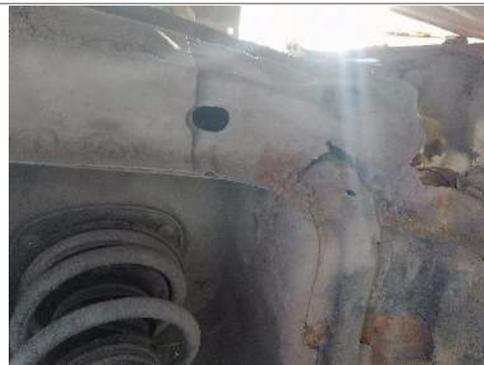
Front Fender Right / Inner Tray

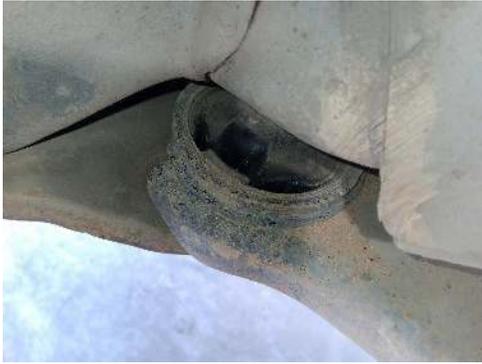
Control Arm Bush(es) Front Axle Right
