## CONDITION REPORT

Report No: 2016364470

| Manufacturer | TOYOTA | Registration Number | FKF675L |
| Model | AVANZA | Register Number | |

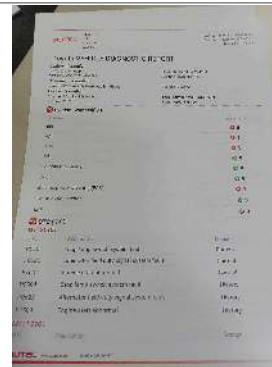
### Brake and shock test

| Damage | Repair Way |
|---|---|
| Shock Absorber Rear Right Worn | Replace |
| Brakes Insufficient | Repair |

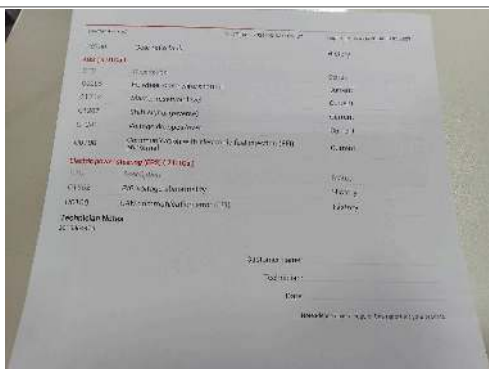
## Diagnostic report

During the diagnostic the following error messages were detected: (See also attached Diagnostic Report. For more information regarding the Fault Codes (DTC) and the recommended rectifications please contact the workshops of the vehicle manufacture).

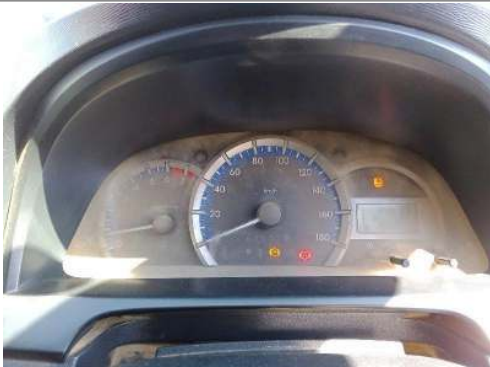
### DASHBOARD (W/ ENGINE RUNNING)

| Damage | Repair Way |
|---|---|
| Engine Management Lights Set | Repair |

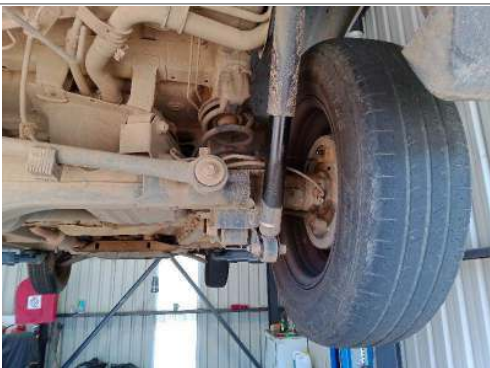
RR TYRE TREAD

| Damage | Repair Way |
|---|---|
| Tyre Rear Right Worn | Replace |

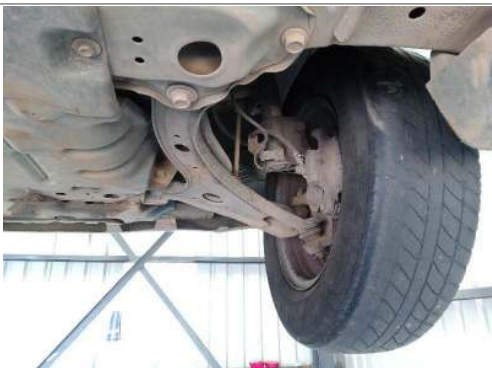
RF TYRE TREAD

| Damage | Repair Way |
|---|---|
| Tyre Front Right Worn | Replace |
